Inoperative Steering Wheel Controls After the Ignition Switch has Been Turned Off for Two Minutes

YEAR(S)	MODEL(S)	ADDITIONAL INFORMATION
2021	RAV4 Prime

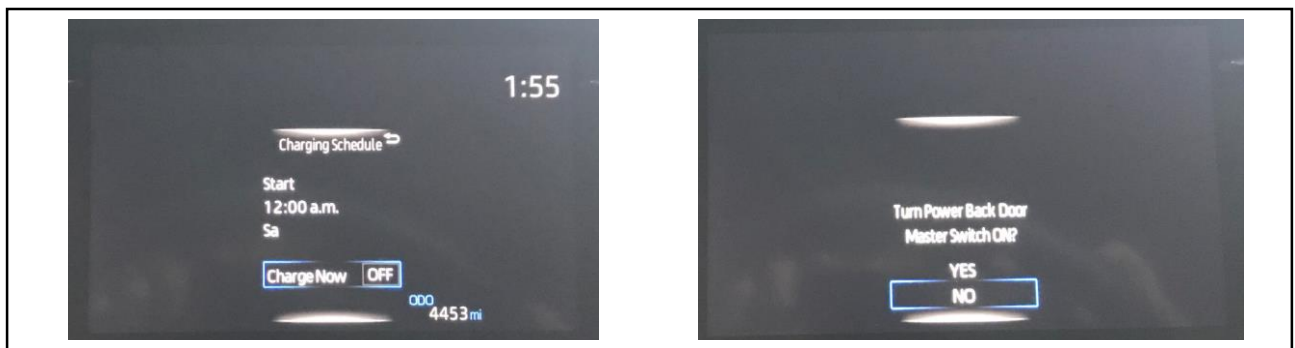
Figure 1.

Some 2021 model year RAV4 Prime vehicles may exhibit a condition in which the steering wheel controls are inoperative after the ignition switch has been turned off for two minutes.

- Unable to select the Charge Now function after the charging cable is plugged in, with a charging schedule set.
- Unable to turn the Power Back Door Master Switch on, when the power back door button is pressed with the power back door system turned off.
- Unable to dismiss warning messages such as “door open” or “window open.”

The combination meter logic has been modified to reduce the possibility of this condition. Follow the Repair Procedure in this bulletin to address this condition.
