SERVICE BULLETIN

APPLICABILITY: 2014-2017MY Forester

NUMBER: 10-87-17

SUBJECT: Rattling Sound from Instrument Panel

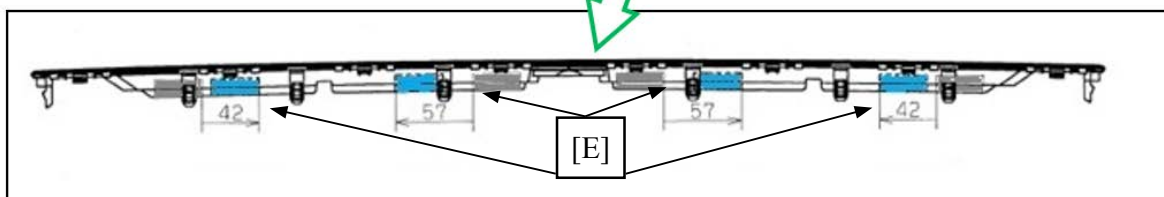
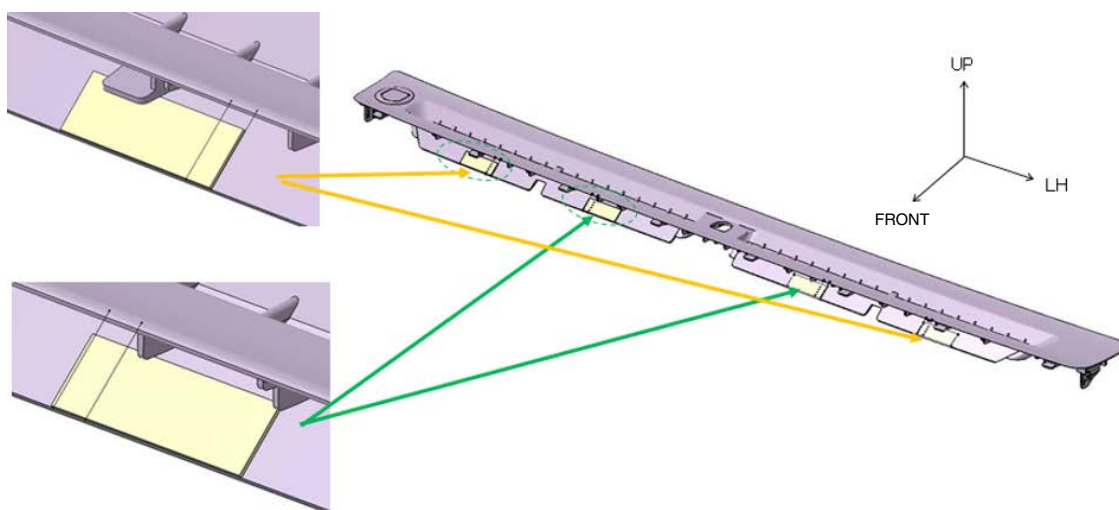
NOTE: The 42mm and 57mm dimensions shown in the illustration are approximate measurements to help with proper positioning of the tapes.

- Using the illustrations below, position and apply the 4 new tapes [E] to underside of the defroster vent grille. The dimensions for the tapes (shown in blue in the first illustration) are:
[E] t = 0.7mm, 12mm x 35mm and may also be layered or stacked to achieve the desired thicknesses.
