INTRODUCTION:

This bulletin outlines a procedure for addressing customer concerns of a creaking sound isolated to the upper right corner of the rear gate area on the models listed above. Over time, repeated twisting motions of the vehicle body may cause the overlapping layers of sheet metal in the affected area shown in the images below to come in contact and generate a creaking-type sound.

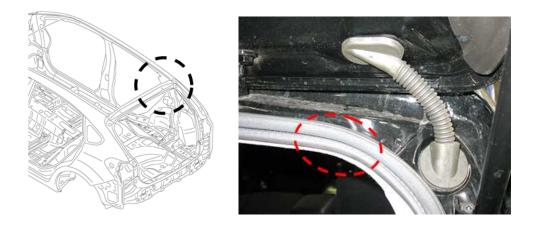
Cross-section view of the affected area
