SERVICE PROGRAM BULLETIN

APPLICABILITY: 2015 MY Legacy & Outback
SUBJECT: Service Campaign – Electronic Parking Brake Reprogramming

NUMBER: WTB-63R
DATE: 04/28/16
Revised: 10/09/20

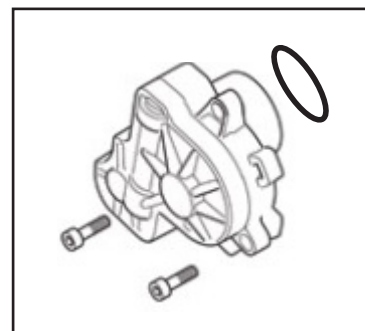
| Description | Part Number | Application |
|---|---|---|
| MOTOR GEAR UNIT KIT-EPB LH | 26669AL010 | Legacy / Outback |

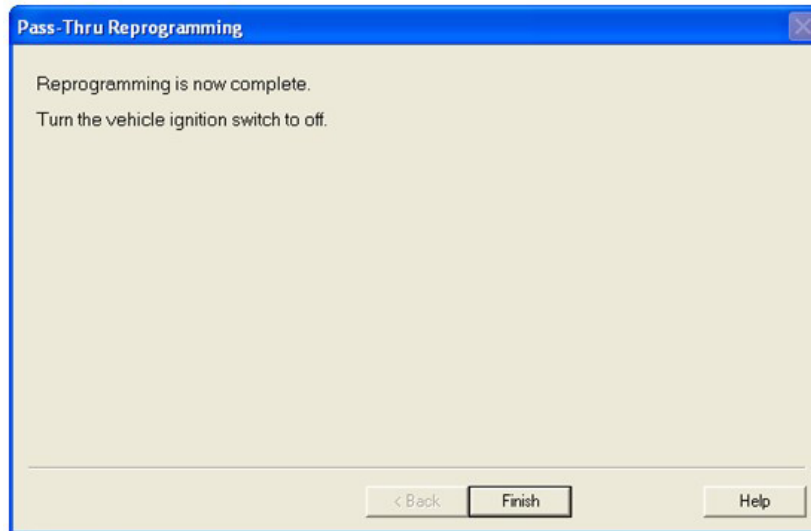
completed successfully, the screen shot shown below will be displayed.

- Reprogram the VDCCM using the normal FlashWrite procedure. When

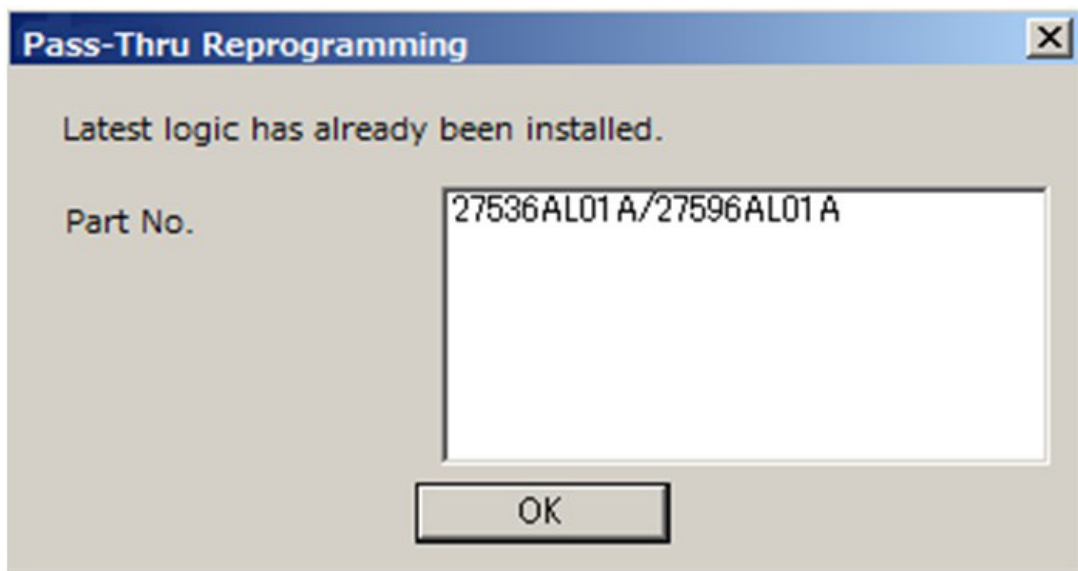
- If the update is not completed as shown in the previous screen shot, perform the reprogramming again and check to see if the “Latest logic has already been installed” screen shot below is displayed. If so, the procedure is complete. If not, perform the reprogramming procedure again.
