# Technical Service Bulletin

## 01 Car jerks/bucks or hesitates while driving DTCs P023600, P010600 are stored in the ECM

01 21 98 2062323/1 February 18, 2021.

Model(s)	Year	VIN Range	Vehicle-Specific Equipment
A6	2018 - 2020	All	2.0TFSI
A6	2021	000001 - 046815	2.0TFSI

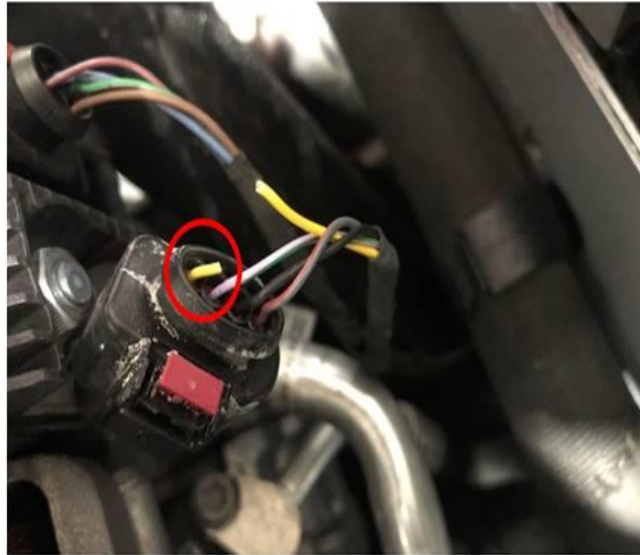
- The yellow wire on the electrical connector of the charge pressure sender is damaged.

Due to the routing of the wiring and the length of wiring that is uncovered, the wiring may become damaged due to vibrations.

*Figure 1. Wire is broken at G31 sensor.*

If damage is found to the pins or wire at the G31 boost pressure sensor, repair the harness using VAS 1978B (Figure 1).

Please use gold-plated contacts to repair the damaged wire(s) (000 979 025 EA).

Ensure there is sufficient slack in the harness to prevent future issues.

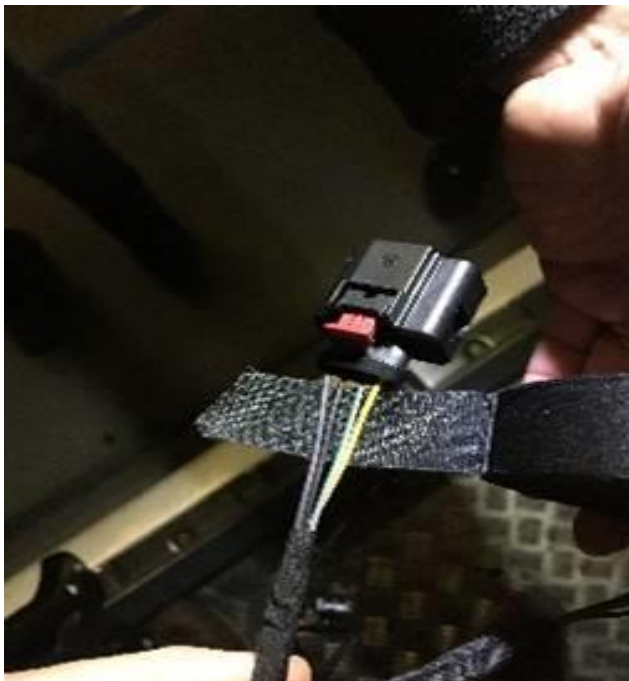
*Figure 2. Harness is wrapped using textile tape 105 920 02.*

Following repairs, the harness must be wrapped with textile tape **N 105 920 02**.

Apply the textile tape starting at the wiring below the connector. Ensure the wires are kept flat to avoid over stressing the pins (Figure 2).

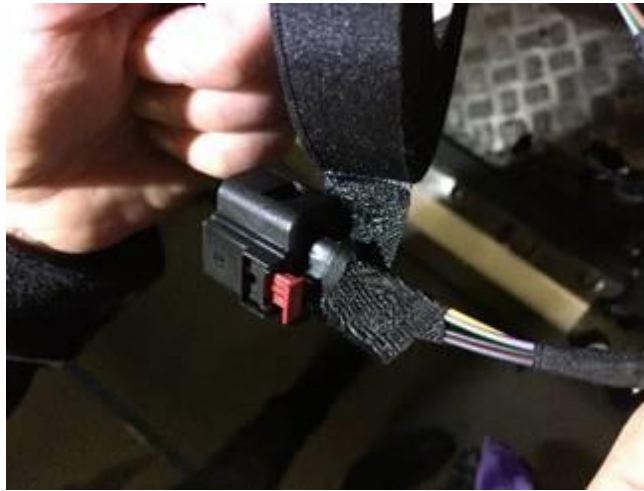
*Figure 3. Wrapping the connector base.*

Wrap the tape in the direction of the connector keeping it **flat** (Figure 3).

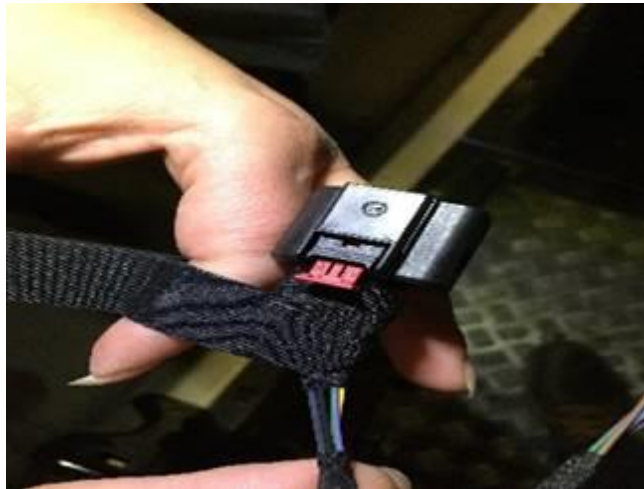
*Figure 4. Wrapping the connector base part 2.*

The tape must extend far enough to cover the connector base (Figure 4).

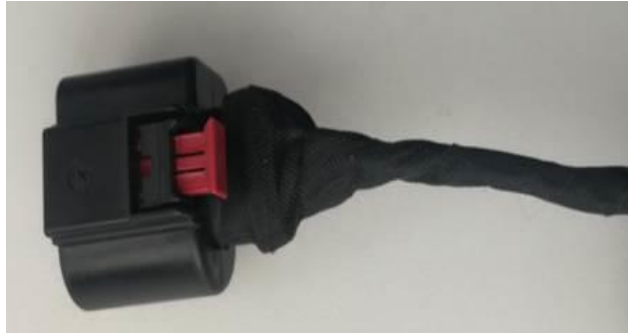
**Figure 5.** Completed harness wrapping.

Continue to wrap the exposed wires down the harness and slightly overlap the existing harness tape (Figure 5).
