# Technical Service Bulletin

**91 Rear MMI control panel (SCON) shows the message: "software update could not be downloaded"**

91 21 66 2062264/1 February 16, 2021.

Model(s)	Year	VIN Range	Vehicle-Specific Equipment
A6, A6 allroad, A6 Avant, S6 RS 6 Avant, A8, S8, Q7, SQ7, Q8, SQ8, and RS Q8	2021	All	RSE

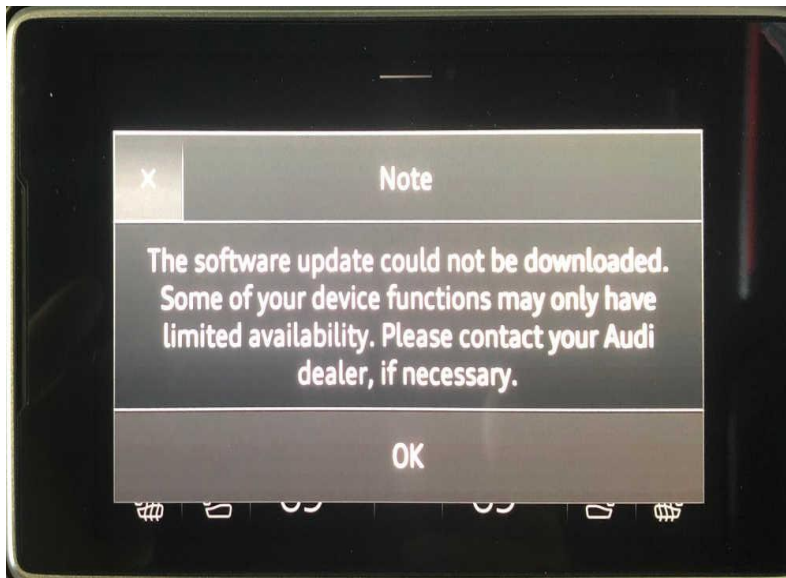
- The message "The software update could not be downloaded..." is displayed on the wireless control head (Figure 1).

*Figure 1. Message displayed on the wireless control head.*

A software malfunction in MIB3 vehicles causes the message to be displayed erroneously.
