# AfterSales Diagnostic Sheet

**MAS002325**  
(BOL 21-04)

## ESC WARNING LIGHT ON – DTC C1240-76 ON SCCM MODULE

**Issue:** ESC WARNING LIGHT ON – DTC C1240-76 IN THE SCCM MODULE  
**Models:** M157/M156/M161

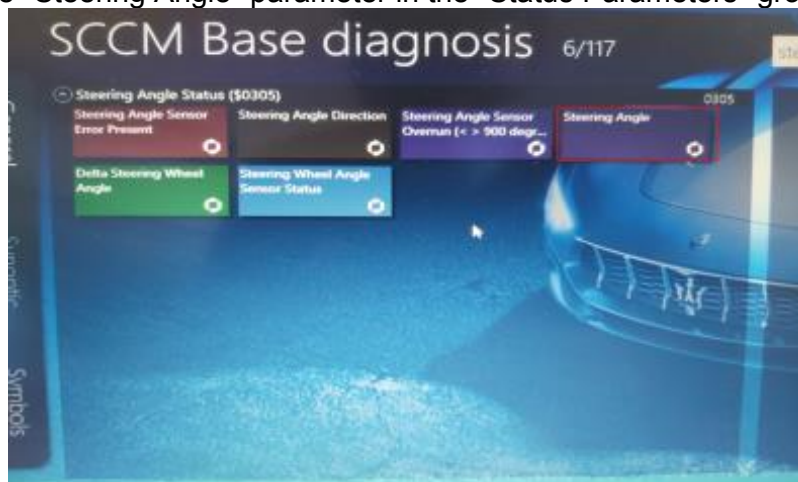
Figure 1

- Connect the diagnostic tool and check, inside the “Base Diagnosis” of the SCCM ecu. Look at the "Steering Angle" parameter in the "Status Parameters" group (Figure 1).

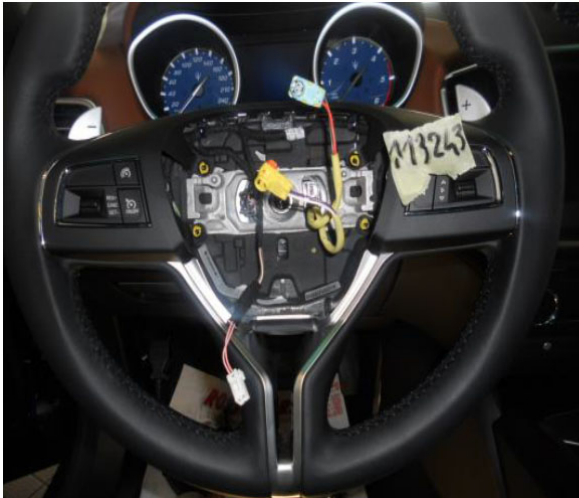
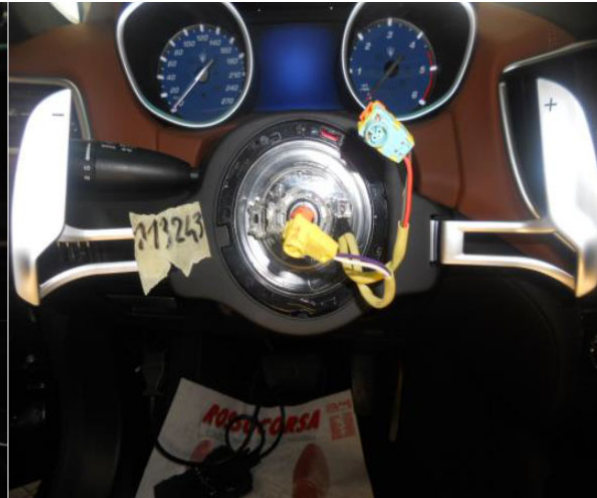
Figure 2

- With the steering wheel and vehicle wheels straight ahead, if the value of the Steering Angle displayed is different than  $0 \pm 5$  degrees, follow the Workshop Manual Procedures "STEERING WHEEL - Removal/refitting or replacement" to reposition the steering column stalk assembly (Figures 2 and 3)

- For the repositioning of the steering column switch the procedures are:
  - a) Be sure to have the steering wheel and the vehicle wheels straight ahead.
  - b) Turn the steering column switch to either the right or left limit. (End of travel)
  - c) Now turn it to the other limit counting the number of turns.
  - d) Turn it back the half number turns in order to be centered.
  - e) Check again with MD Evo the value of the parameter "Steering Angle" making sure it has returned to  $0 \pm 5$  degrees.
