- SIB 61 27 20

2021-01-21

**CHECKING THE JUMP START POINT COVER AND REWORKING IF NECESSARY**

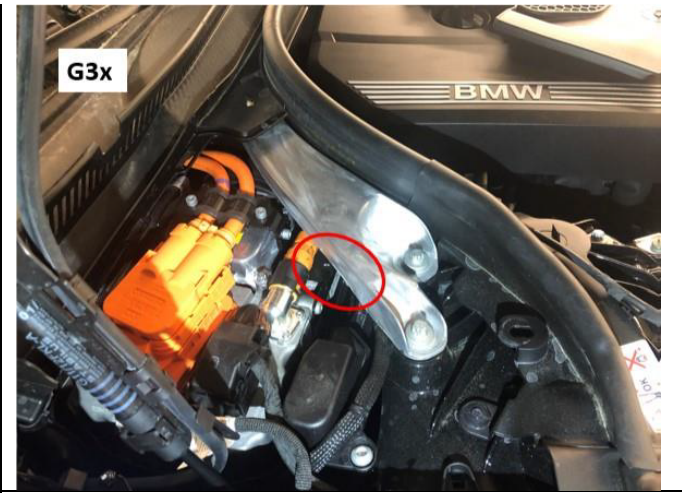
<ul style="list-style-type: none"> <li>Access the engine bay passenger side rear section and remove the cover as shown.</li> </ul> <p>(see reference picture for G2x vehicles)</p>
--	--

Inspect the jump start terminal point cover for tight fit, or install the cover if missing.

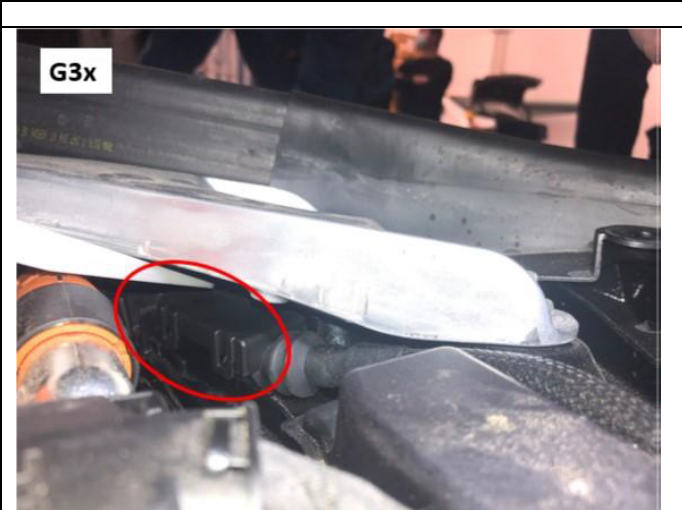
<p><b>G2x</b></p>	<ul style="list-style-type: none"> <li>• Check the cover for a tight fit and that the plastic tabs are properly secure as shown on the picture.</li> </ul> <p>If necessary, install the cover correctly by pressing it down with your finger or with a plastic panel wedge to lock the plastic tabs.</p> <ul style="list-style-type: none"> <li>• If the cover is missing, it must be installed. Disassemble the strut brace in accordance with repair instructions 51 71 341 (strut brace).</li> </ul>
