- SIB 63 07 20

2021-01-04

FRONT DOOR PANEL LED FAILURES

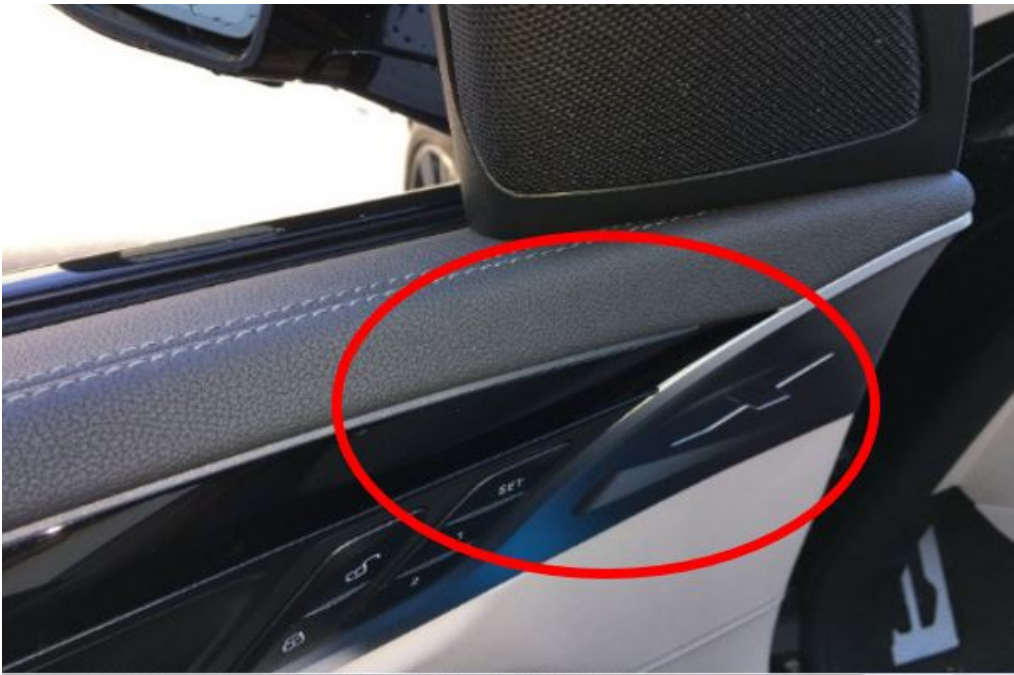
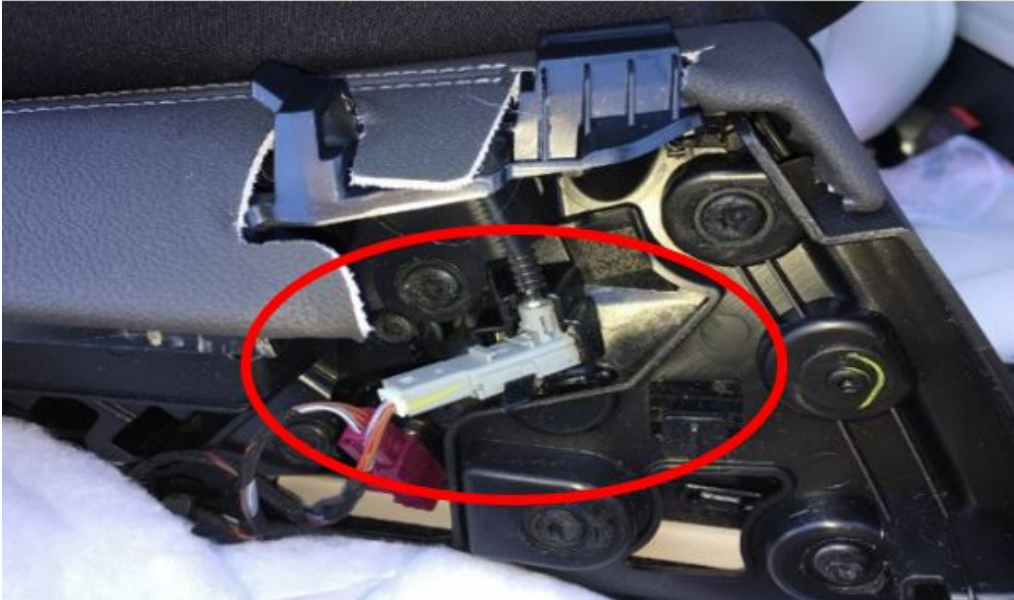
G01 and G02 location shown below:

The LED light on the front door is not working. Depending on the model, the location of the light will be different.

Due to the orientation of the LED module, moisture may enter the LED module, causing corrosion.

Replace the affected LED module and seal the replacement LED module.
