- SIB 66 21 19

2021-01-21

LDW (LANE DEPARTURE WARNING): STEERING WHEEL VIBRATION NOT STRONG

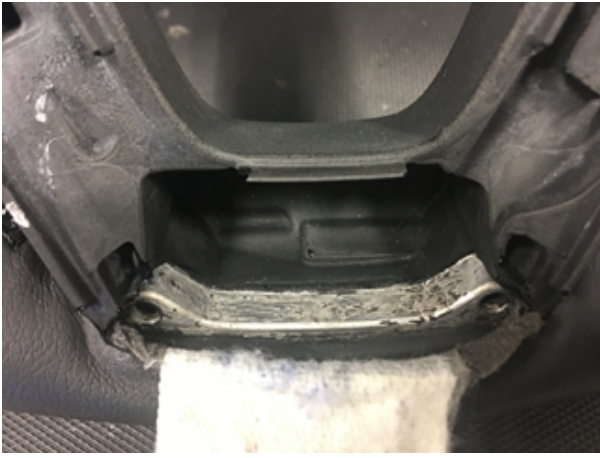
10. This image shows the rubber material coating on the steering wheel removed where the vibration actuator is mounted.

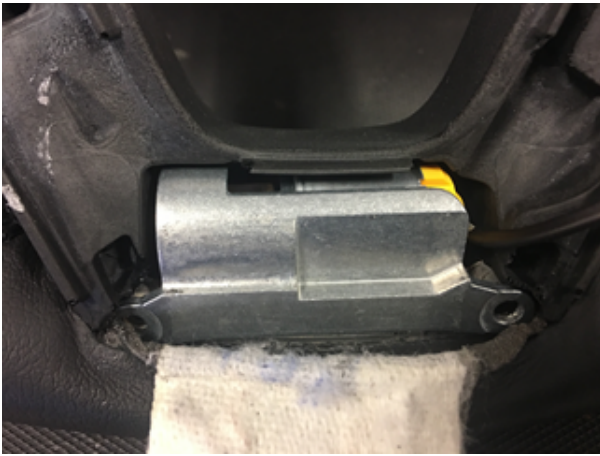
11. Image shows the vibration actuator with the insulation removed.
