Service Bulletin

20-049

2018-21 Odyssey: Popping or Crackling from the Speakers; No Sound from the Audio System; *Network Loss* Message and/or Display Issues Supersedes 20-049, dated October 12, 2020, to revise the information highlighted in yellow.

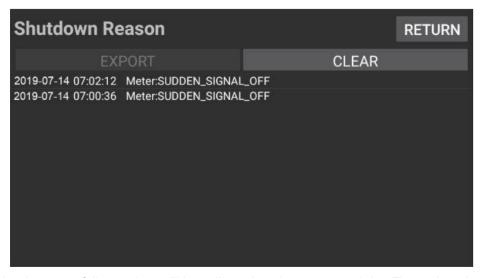
In this example, the cause of the failure can be identified as Meter:SUDDEN_SIGNAL_OFF.

Write down any failures; they will be collected on the warranty claim. Then, clear the data.
