February 18, 2021

Version 1

## Warranty Extension: 2019-20 Passport/Pilot MOST Bus Network Connectors

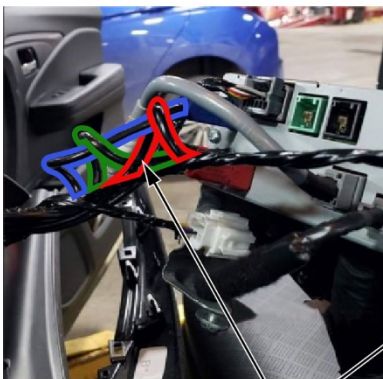
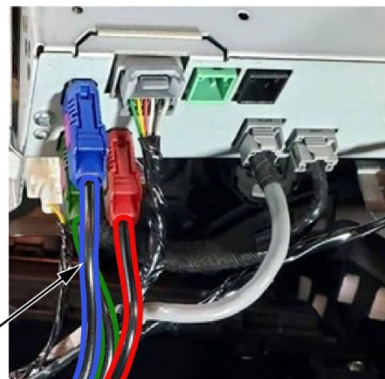
**HARNESS**  
Reroute.

23. Install all of the removed parts in the reverse order of removal. When installing units, make sure the harness is routed correctly because a misrouted harness can put pressure on the connectors, which can cause a connection issue. Do not pull on the units or MOST service cords while the FAKRA connectors are connected to help prevent communication issues.
