February 18, 2021

Version 1

**Warranty Extension: 2018-20 Odyssey MOST Bus Network Connectors****AFFECTED VEHICLES**

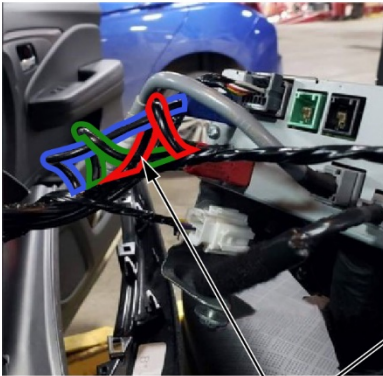
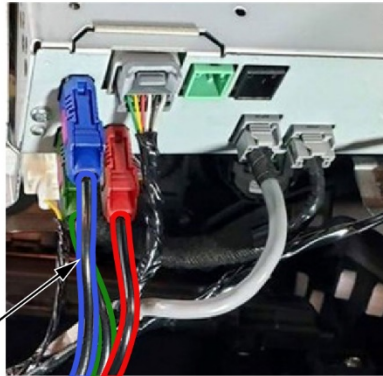
31. Install all of the removed parts in the reverse order of removal. When installing units, make sure the harness is routed correctly, as a missrouted harness can put pressure on the connectors which may cause a connection issue. Do not pull on the units while the FAKRA connectors are connected to help prevent communication issues.

**HARNESS**  
Reroute.
