February 18, 2021

Version 6

Popping/Crackling from the Speakers; Display Blank

Supersedes 20-031, dated February 10, 2021, to revise the information highlighted in **yellow**.

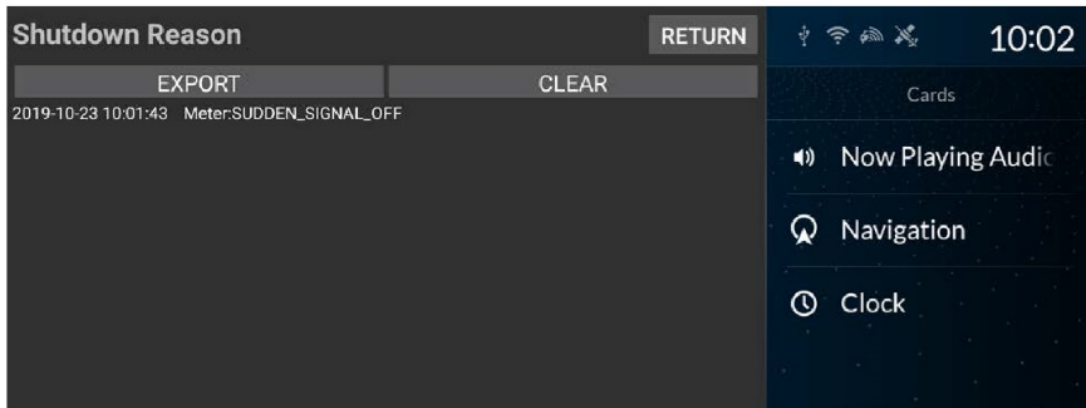
In this example, the cause of the failure can be identified as **Meter:SUDDEN_SIGNAL_OFF**.

5. Write down any failures as they will be collected on the warranty claim. Then, clear the data.

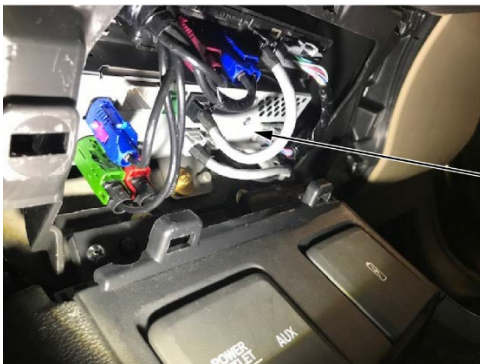
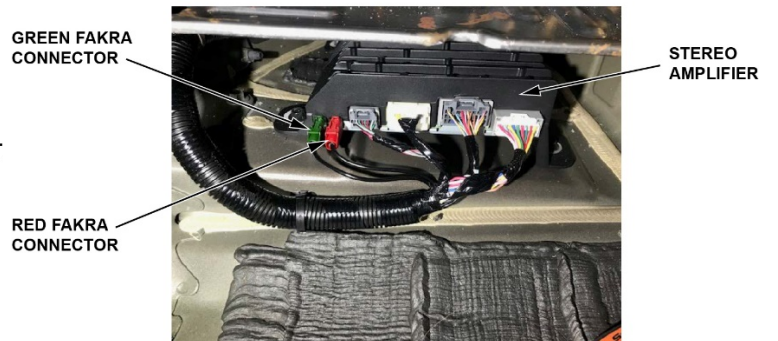
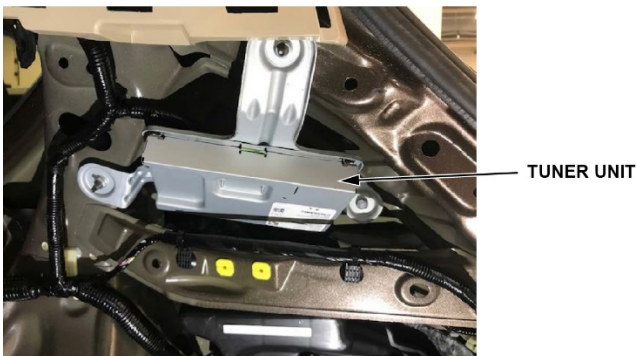
There is a loose connection in the MOST bus network.

19. Disconnect the red and green MOST connectors at the infotainment, stereo amplifier, and tuner units using the straight FAKRA puller.

NOTE: To avoid mixing up the wires, remove only one FAKRA connector at a time.
