Business Class M2
Cascadia
108SD/114SD
> New Cascadia

**Freightliner
Service Bulletin**

New Cascadia vehicles built from September 9, 2019 through October 1, 2020, with the tire pressure monitoring system (TPMS) modules communicating on the J1939 500K baud rate (part numbers BW K138367 or BW K165667) and stamped with the TPMS housing date codes from February 2019 to June 2019, may experience water intrusion into the TPMS module.

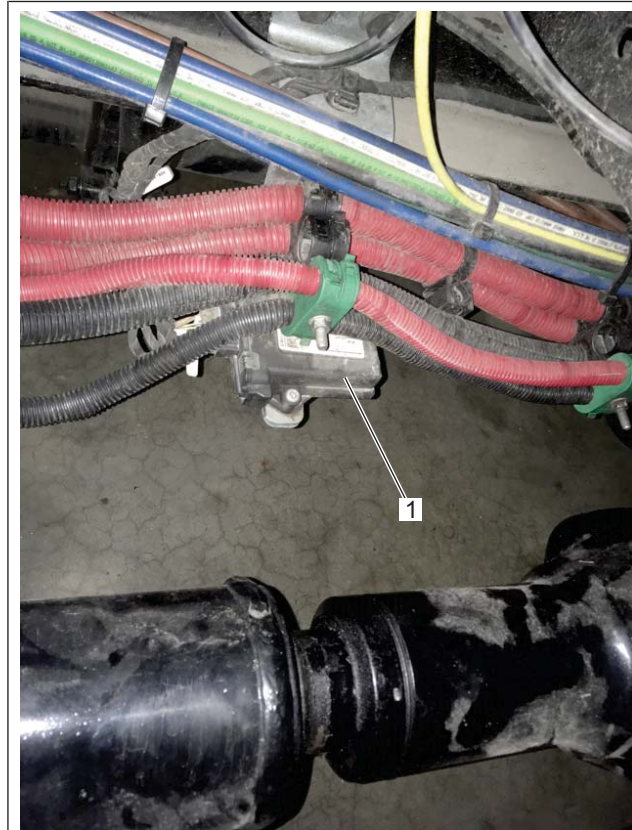
Fig. 1, Location of the TPMS Module

1. Park the vehicle on a level surface, shut down the engine, and set the parking brakes. Chock the tires.
2. Locate the TPMS module mounted below the left frame rail as shown in [Fig. 1](#).

If the vehicle has either of the listed symptoms and the TPMS module is stamped with a date code of February 2019 to June 2019, it is recommended that the module be replaced. Ensure the connection at the module is not damaged; replace any damaged parts.

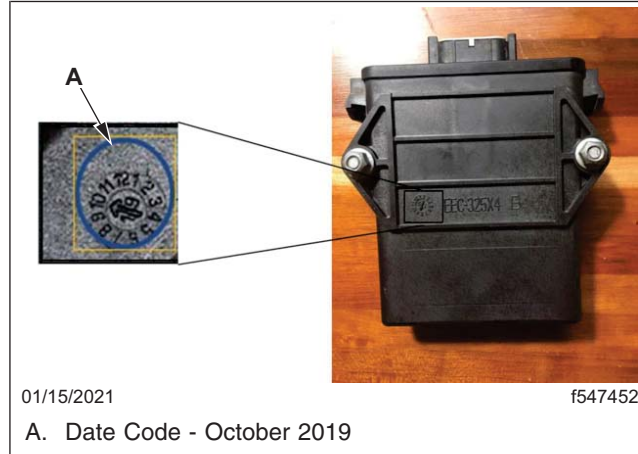
Fig. 4, TPMS Housing Date Code

5. Inspect the TPMS housing date code. If the date is between February 2019 and June 2019, replace the TPMS module. See [Fig. 4](#) for the location of the date code.
