February 18, 2021

## Warranty Extension: 2019-20 RDX MOST Bus Network Connectors

### AFFECTED VEHICLES

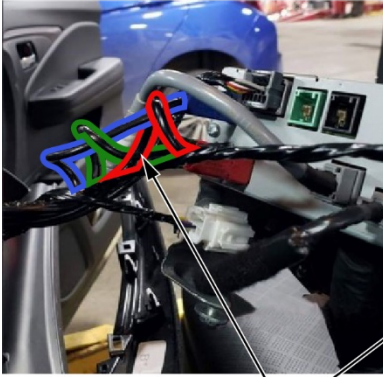
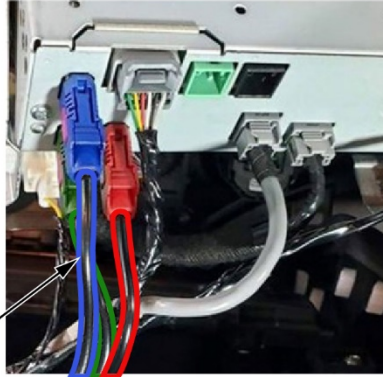
25. Install all the removed parts in the reverse order of removal. When installing the units, make sure the harness is routed correctly as a misrouted harness can put pressure on the connectors which may cause a connection issue. Do not pull on the units while the FAKRA connectors are connected to help prevent communication issues.

**HARNESS**  
Reroute.
