2021 CMX1100
(Rebel 1100)

February 2021

the
wrench
Honda Technician Newsletter

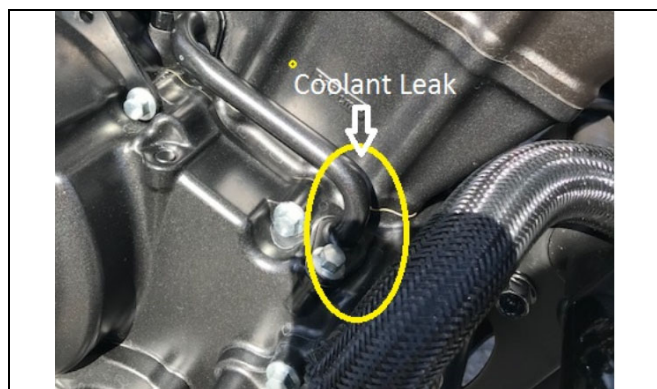
COOLANT LEAK - RIGHT ENGINE COVER (‘19 CMX300, CB300R, CBR300R, CRF250L/RALLY)

If the right engine cover is leaking coolant on any of the models listed, this could be due to the water pipe causing a gap at the clutch cover side. Replacing the O-ring will not fix the leak. Instead, replace the water pipe.

Use 19120-KYJ-900 to repair CMX300, CB300R and CBR300R.

Use 19120-KZZ-900 to repair CRF250L and CRF250L Rally.

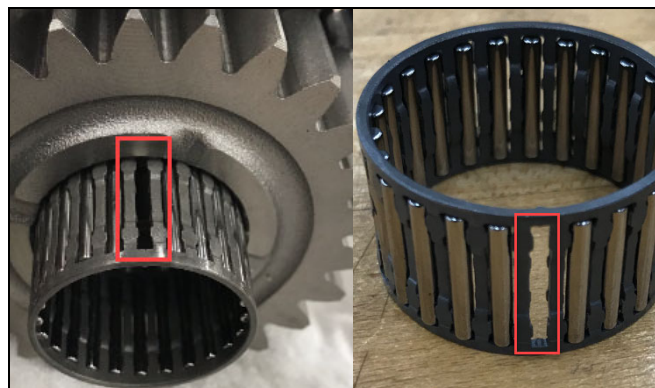
NEEDLE BEARING NOT MISSING (‘16 AND NEWER PIONEER 1000, ‘19 AND NEWER TALON)

When rebuilding a Pioneer 1000 or Talon sub transmission, there are two caged needle bearings which appear to be missing one needle on each cage (P/Ns 91027-HL4-003, 91022-HL4-003). This is normal. The space is where the cage is welded together. The needle is left out for sizing reasons. See image below for reference.
