# TECHNICAL SERVICE BULLETIN

Technical Service Bulletin: 203-1287

Forest River is alerting you to an issue involving certain 2021 Catalina BCAT184BHS travel trailer Recreational Vehicles. Please see the information below, which describes the issue and provides you with details on the steps you should take to have your vehicle repaired.

On certain vehicles, the air conditioner diverter is installed incorrectly.

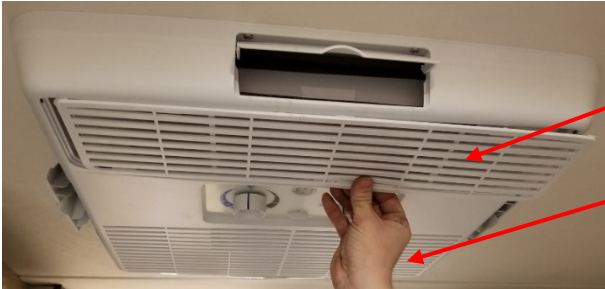
Locate the interior A/C shroud.

The "SMALL" grill will be on the rearward side (incorrect)

The "LARGE" grill will be on the forward side (incorrect)

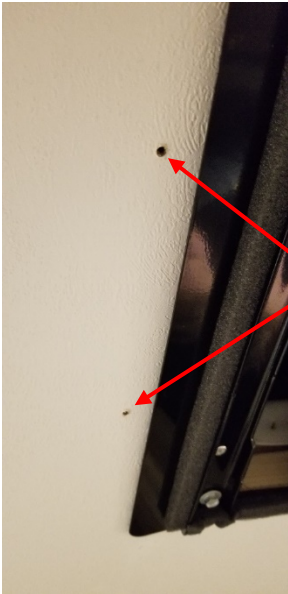
With the interior A/C chassis rotated, on the forward side, there is a potential for two screw holes to be left exposed. These will need to be filled and repaired so they are not visible.

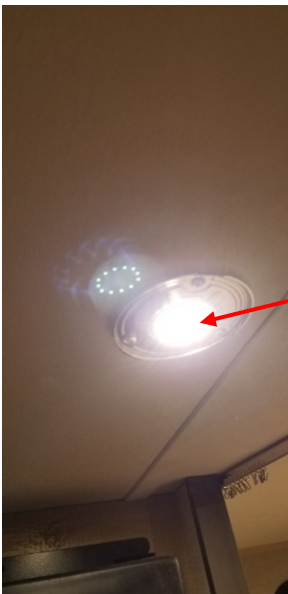
With the interior A/C chassis rotated, on the rearward side, there is a potential for the ceiling light to interfere with the plastic A/C shroud. Move the ceiling light rearward just enough to miss the A/C shroud and still hide any holes it may leave.
