Emissions Recall

Code: 26N6

Subject	Catalyst															
Release Date	February 24, 2021															
REVISION SUMMARY	Updated claiming instructions, part information and work instructions with latest catalyst information. Removed part ordering restrictions.															
Affected Vehicles

Subject: Emissions Recall 26N6 - Catalyst

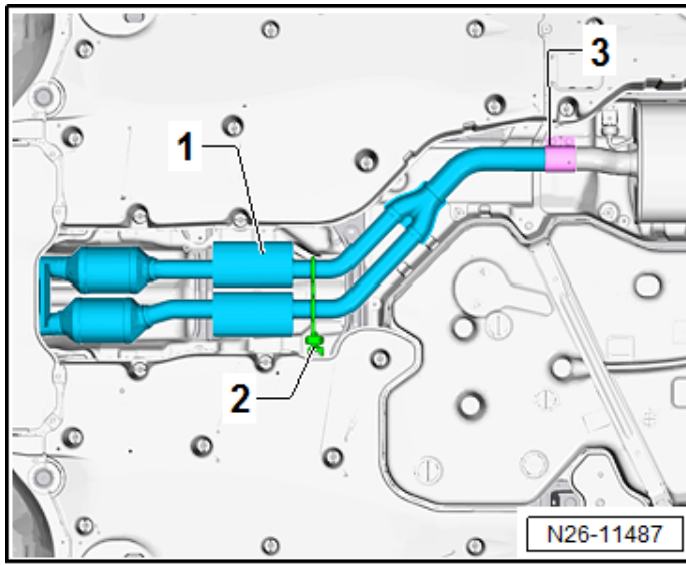
Repair Overview

What is the issue?	Over time and mileage, the factory-installed catalyst may not perform as required. If the effectiveness of the catalyst is reduced, this may result in increased tailpipe emissions and the vehicle could fail an emissions (IM) inspection.
What will we do?	Your authorized Volkswagen dealer will replace the catalyst and update the ECM software in your vehicle. This work will take about four (4) hours to complete and will be performed for you free of charge. Please keep in mind that your dealer may need additional time for the preparation of the repair, as well as to accommodate their daily workshop schedule. IMPORTANT! If the ECM in your vehicle has been “chipped,” “tuned,” or otherwise modified from original factory specifications with aftermarket components and/or software, work needed to repair, replace, or return the ECM to original factory specifications is NOT covered under this action.

- Replace catalyst and update ECM software.

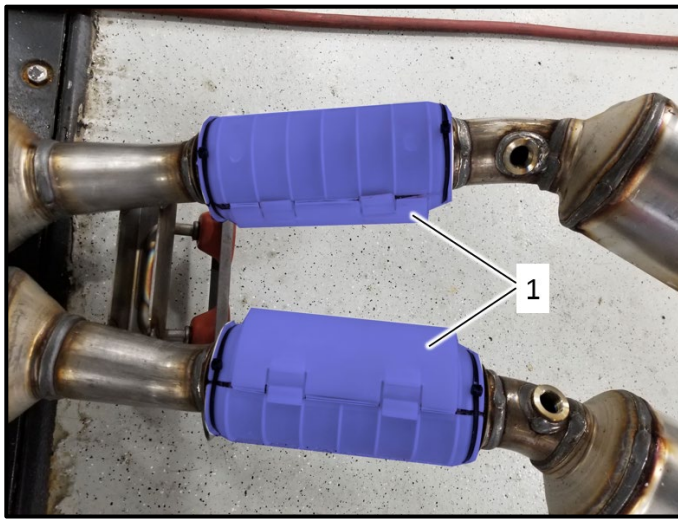
Do not bend the decoupling element more than 10°. Do not damage the wire mesh on the decoupling element.

- Ensure the transportation protection <1> is secured on the new catalyst before installing.
- After installing and securing the catalyst to the exhaust manifold, remove the transportation protection from the catalyts.

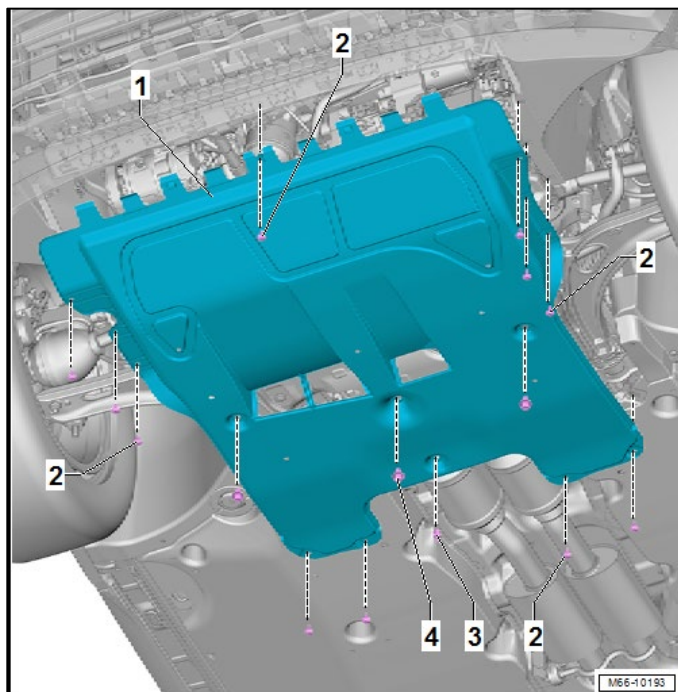
This rivet is required to prevent noise and to prevent debris from building up on the top of the noise insulation.

- A new expanding rivet <3> must be installed when reinstalling the noise insulation.
