Technical Service Bulletin

91 MIB2 High Navigation Software Update Instructions (PR Code 7UG)

91 21 72 2047576/6 February 25, 2021. Supersedes Technical Service Bulletin Group 91 number 20-50 dated December 17, 2020 for reasons listed below.

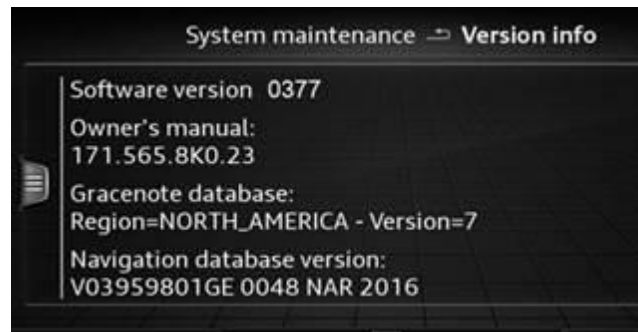
1. To save time, always verify the customer's MMI requires the software update before proceeding. In the MMI, go to *Menu >> Settings >> Left drawer option >> Version Information* (Figure 1). This applies to models using the new MIB2 user interface. The C7 PA uses the old user interface similar to MMI3G+ along with the newer MIB2 hardware. The software version for the older user interface is found under *Menu >> Setup MMI >> Version Information*.

Figure 1. MIB2 Software Version in MMI with a new UI.
