Technical Service Bulletin

94 Rear turn signal warning is displayed, DTCs B16D4F4, B16D5F4, B16D6F4, or B16D7F4 are stored in the comfort module

94 21 35 2062241/1 February 23, 2021.

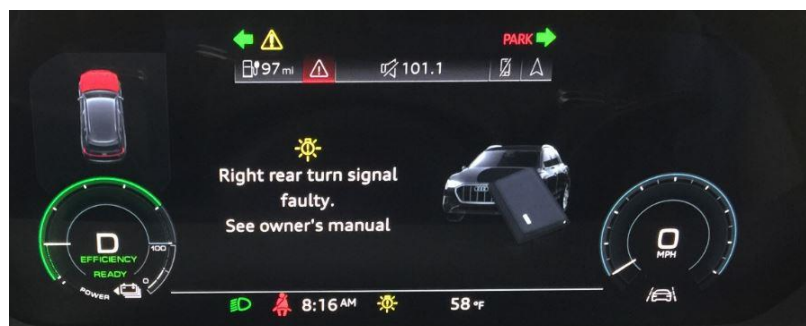
There is a timing issue in the tail lamp software.

1. When actuating the turn signal, a warning is displayed for the rear turn signal that was actuated (Figure 1).

Figure 1. Warning displayed for right rear turn signal.

2. If the described condition is present, please proceed to update the software in the tail lamps.

3. Follow all instructions in TSB 2011732: 00 Software Version Management (SVM), operating instructions.
4. Update the tail lamp software using the SVM action code as listed in the table below, if necessary:
