02/23/2021
CAL FTL 32-009

**Subject: New Cascadia Front Steer Arm –
Drag Link Ball Joint Connection Inspection**

**Models Affected: Specific New Cascadia vehicles manufactured
between June 1, 2019 and July 14, 2020**

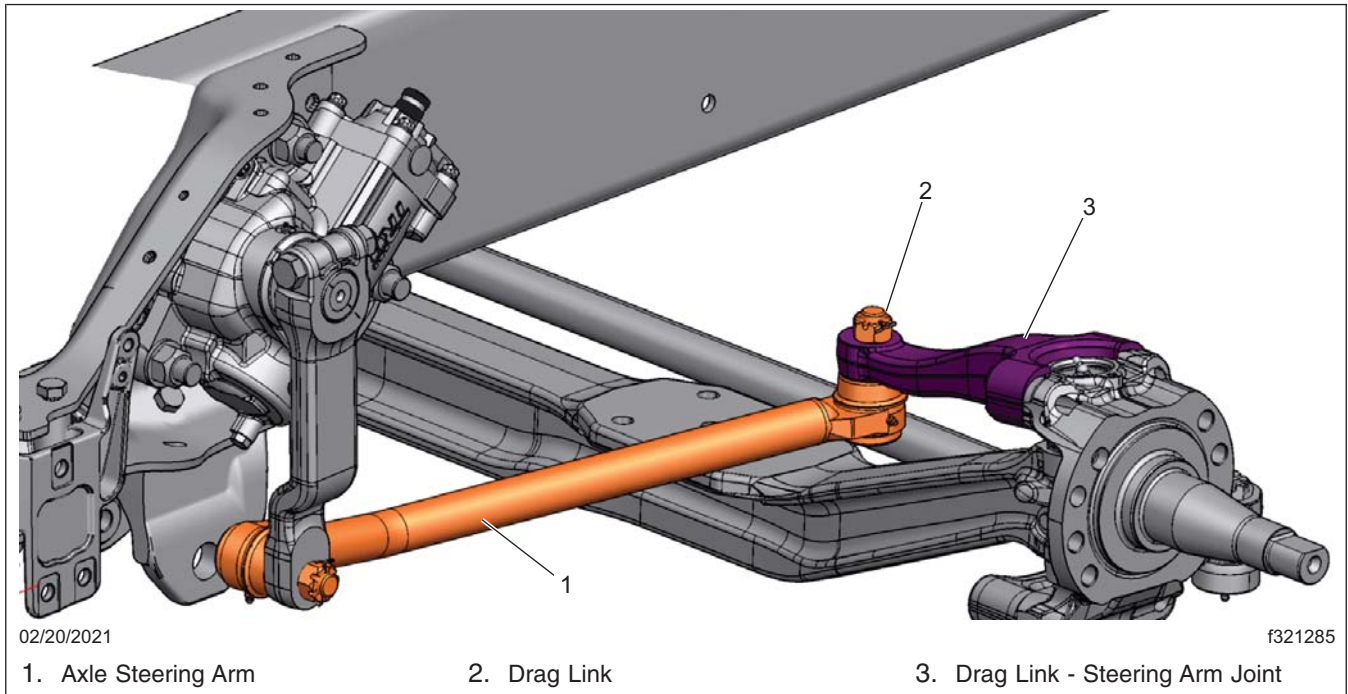
Fig. 1, Drag Link - Steering Arm Joint

- 4.2 While the steering wheel is being turned, have the second person monitor the behavior of the drag link - steering arm joint.

If there is movement in the drag link - steering arm joint, continue to step 6.

6. If relative movement is observed between the drag link ball stud and steering arm connection point, the drag link and steering arm will need to be replaced.
 - 6.1 For steering arm replacement refer to the following manual sections:
 - **New Cascadia Workshop Manual**, section 33.03.110 Detroit Front Axles, Axle Removal and Installation.
 - **Meritor Maintenance Manual 2** for Meritor Front Non-Drive Steer Axles, section 10.
 - 6.2 For drag link replacement refer to the **New Cascadia Workshop Manual**, section 46.06.100 Drag Link Removal and Installation.
