02/23/2021
CAL FTL 32-010

**Subject: Cascadia Front Steer Arm – Drag
Link Ball Joint Connection Inspection**

Models Affected: Specific Cascadia vehicles manufactured between January 1, 2019 and July 14, 2020

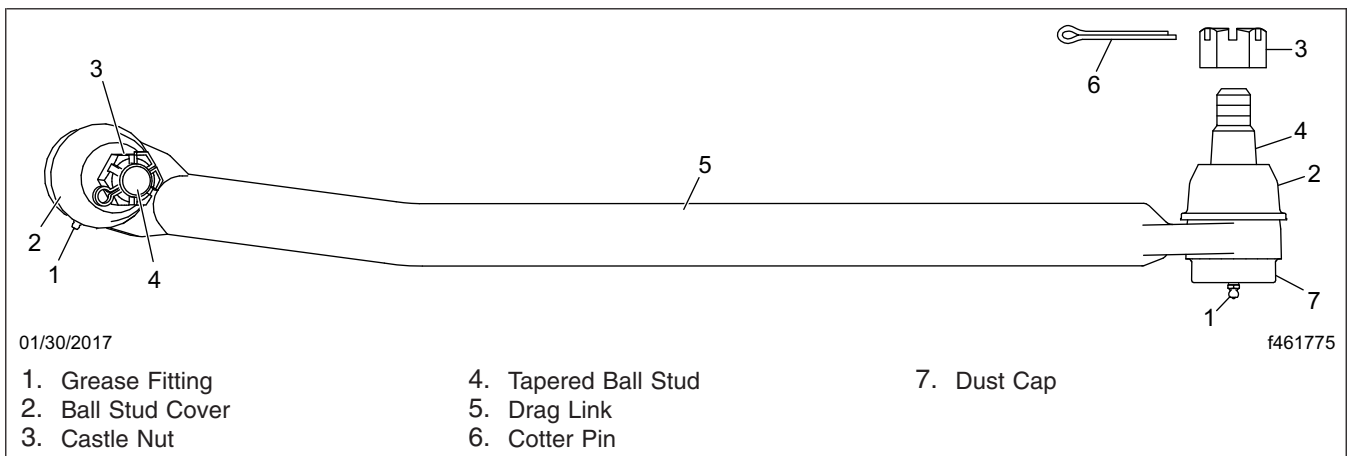
Fig. 2, Fixed-Length Drag Link Assembly

5.1 Remove the cotter pin and torque the castle nut to 229 lbf-ft (310 N·m). See [Fig. 2](#).

5.2 Once the castle nut is torqued, install a new cotter pin. If the new cotter pin does not align, continue to tighten the castle nut to achieve cotter pin alignment. **Do not** loosen the castle nut to allow for alignment of the cotter pin.
