# SS 1034761 P3 - CEL On and Engine de-rate due to ATD Chassis Harness Circuit 532M5+ at DEF Heater Supply location is shorted

**P3 - CEL On and Engine de-rate due to ATD Chassis Harness Circuit 532M5+ at DEF Heater Supply location is shorted.**

**FTL P3 - Cascadia**

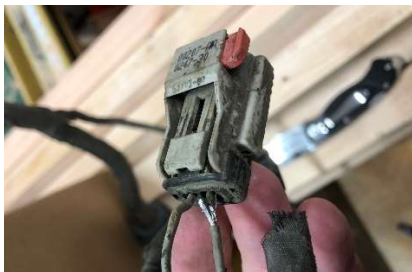
Harness part number A66-03217-002 has been reported experiencing failures due to damages to 532M5+ circuit shorting /or corrosion in terminals at Connector (23-13153-200) harness location "ATD\_CHAS\_F\_O\_HTR\_LINE\_DEF\_5B" .

# Circuit 532M5+ Damaged at DEF Heater Line Connector:

Connector backshell is available to be added at the location indicated to add extra protection to wiring and also reduce or eliminate terminal corrosion.

Required part number: 23-13302-633 -- Backshell

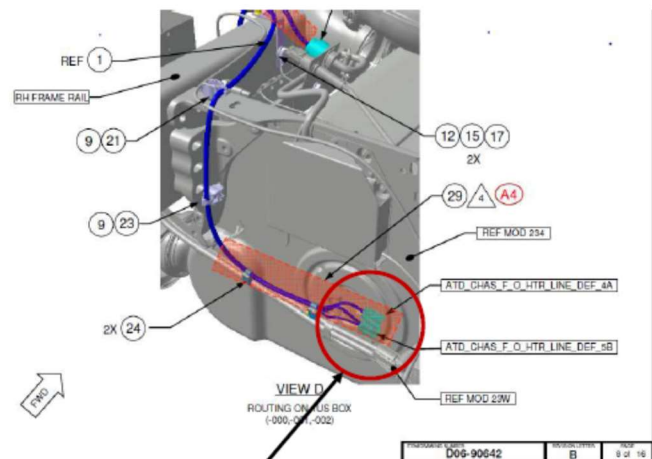
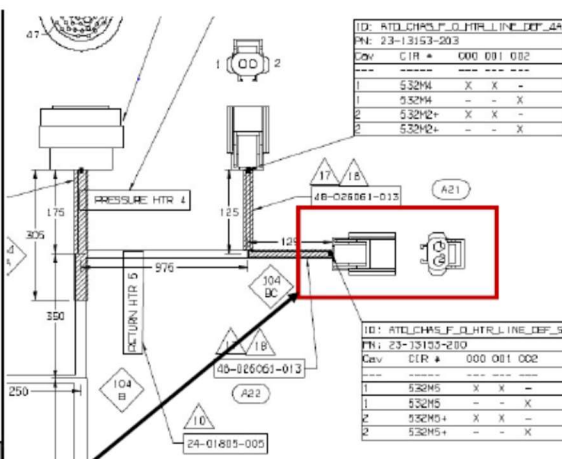
A66-03217-002- ATD Chass-Harn Break-Out location: **ATD\_CHAS F O HTR LINE DEF\_5B**

Addition of Back Shell 23-13302-633 to Connector 23-13153-200in ATD Chassis Harness A66-03217-002
