# SS 1034867 New Cascadia Seat Belt Warning Harness Routing

All New Cascadia

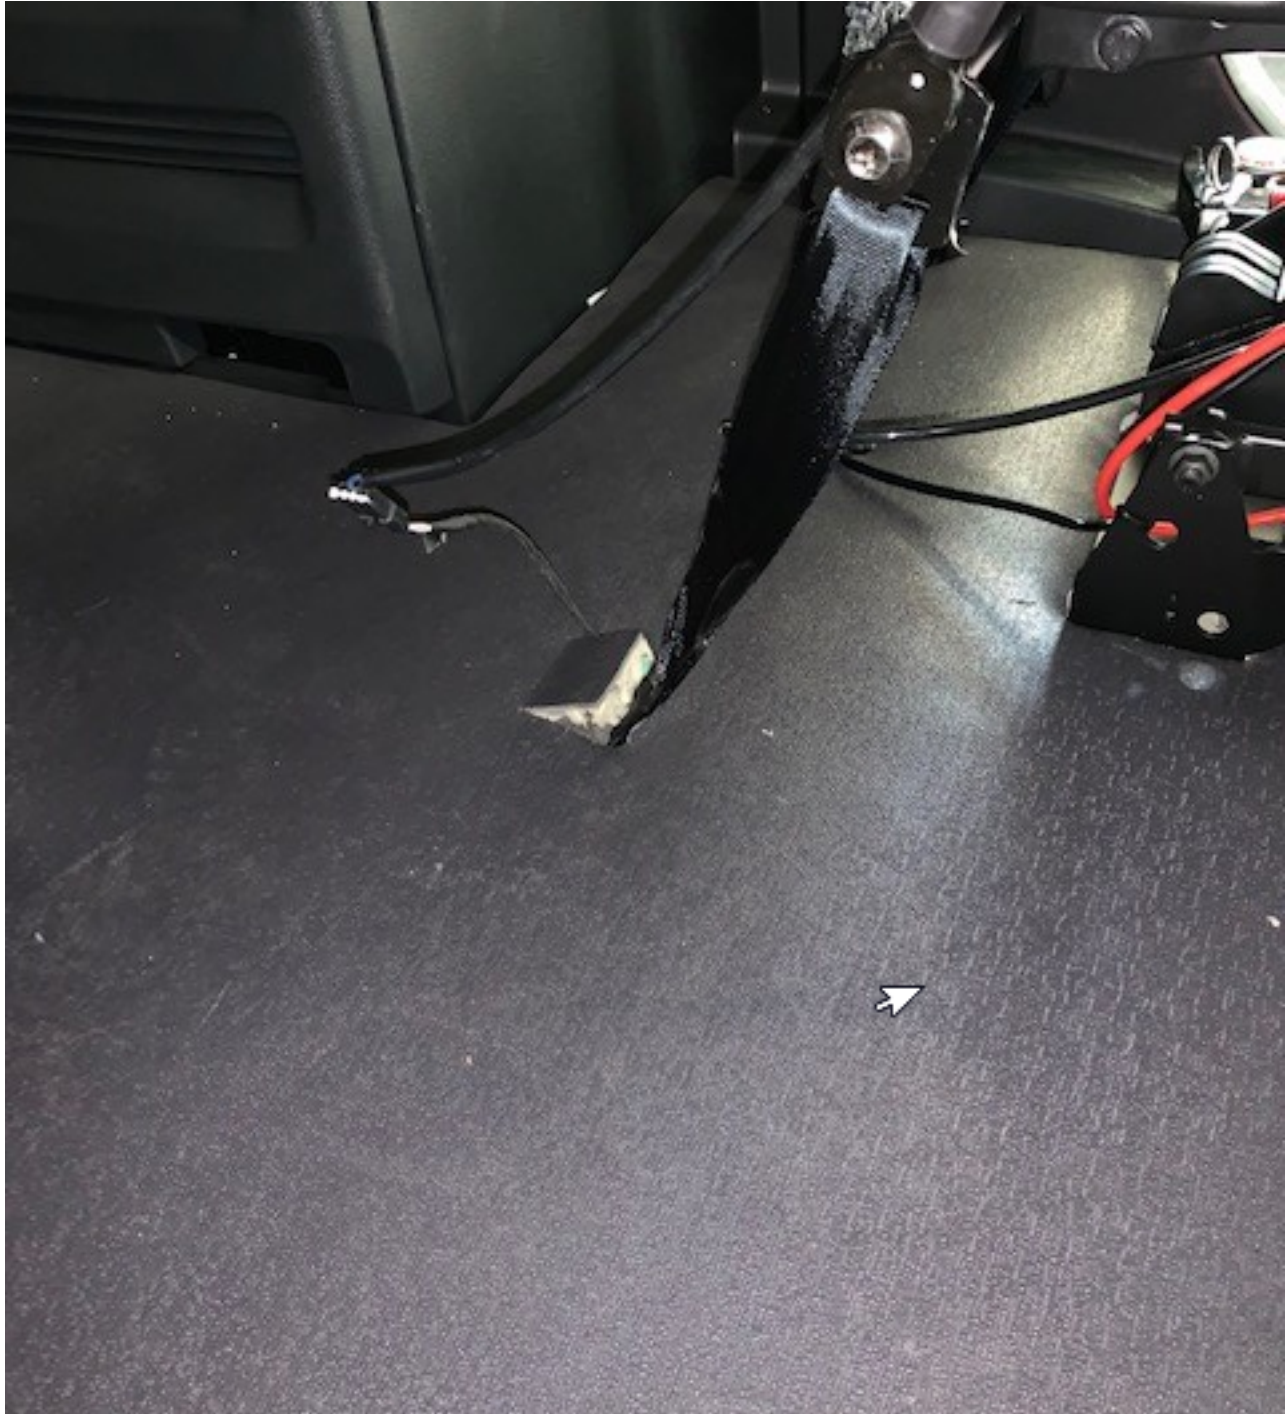
## **Seat Belt Wiring Harness:**

The seat belt warning wiring harness can be damaged or inadvertently disconnected by a driver's foot due to its present installation beside the seat belt.

The current solution is to extend the seat to the top of its travel, then attach the seat belt warning wiring harness to the crossbar portion of the seat assembly to keep the harness clear of foot traffic.
