# SS 1034884 P4 New Cascadia Unintended Dome Lamp Activation Due To Poor Connections at the sSAM

This solution applies to all P4 New Cascadia vehicles.

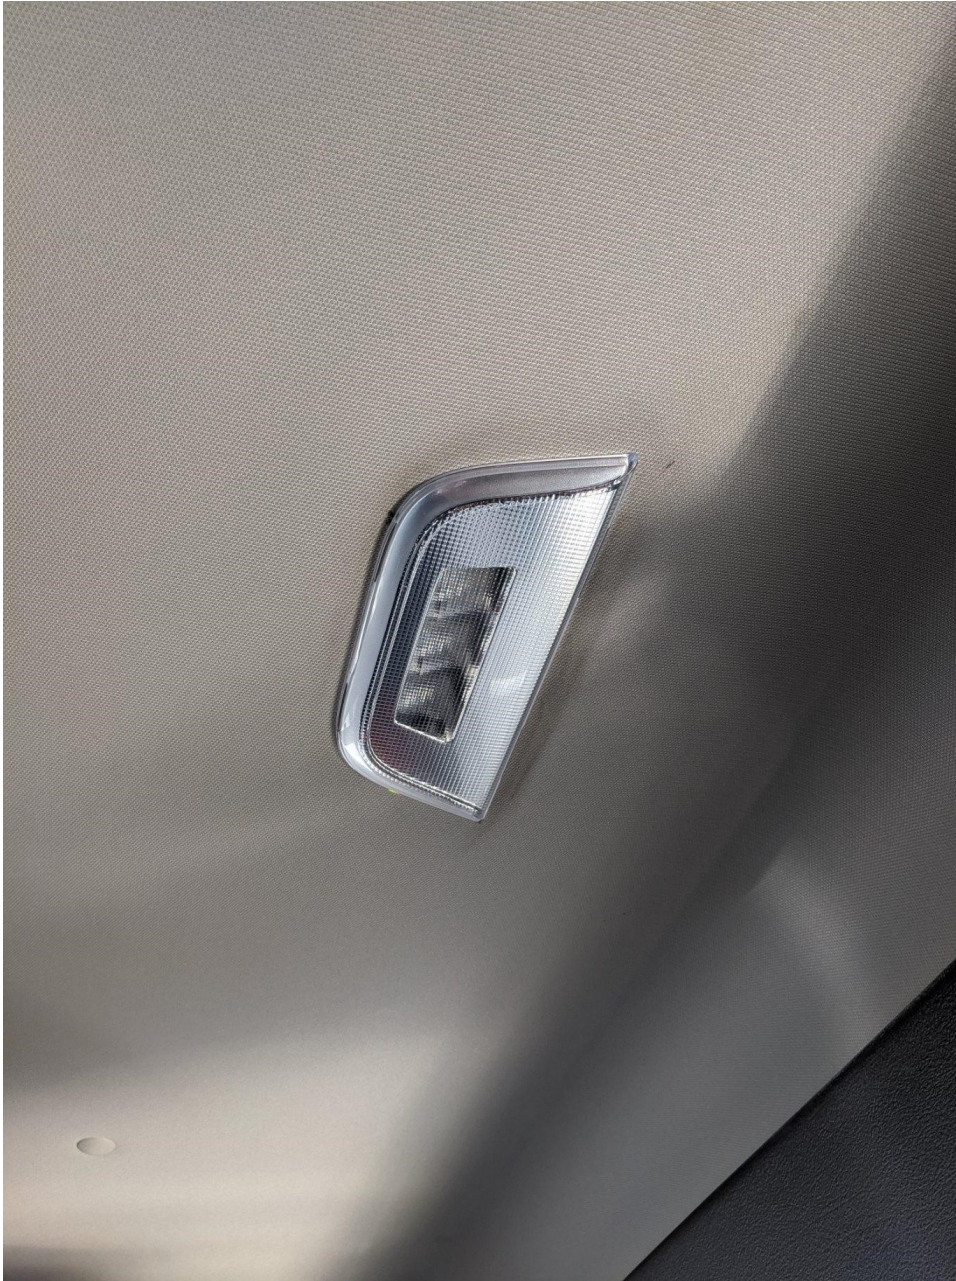
Dome lamp Day Cab

Ignition on, with no dome lamp inputs requested, center dome lamp starts coming on and off slowly or just stays on. Turning off the ignition and or removing power from the sSAM will not eliminate the condition. Also trying to turn the dome lamp off using the dome lamp switch in the dash will not turn off the lamp (see affected dome lamp images below show dome lamps affected). A video is also attached documenting the dome lamp on / off condition that can occur.

If encountering unintended operation of the center dome lamp, check the power and ground connection to the sSAM. There should be no material on the connections at sSAM and the cables need to be clean and properly torqued as embossed on the sSAM body (12NM, "9 Ft LBS") using patch lock nut P/N 23-14592-008.

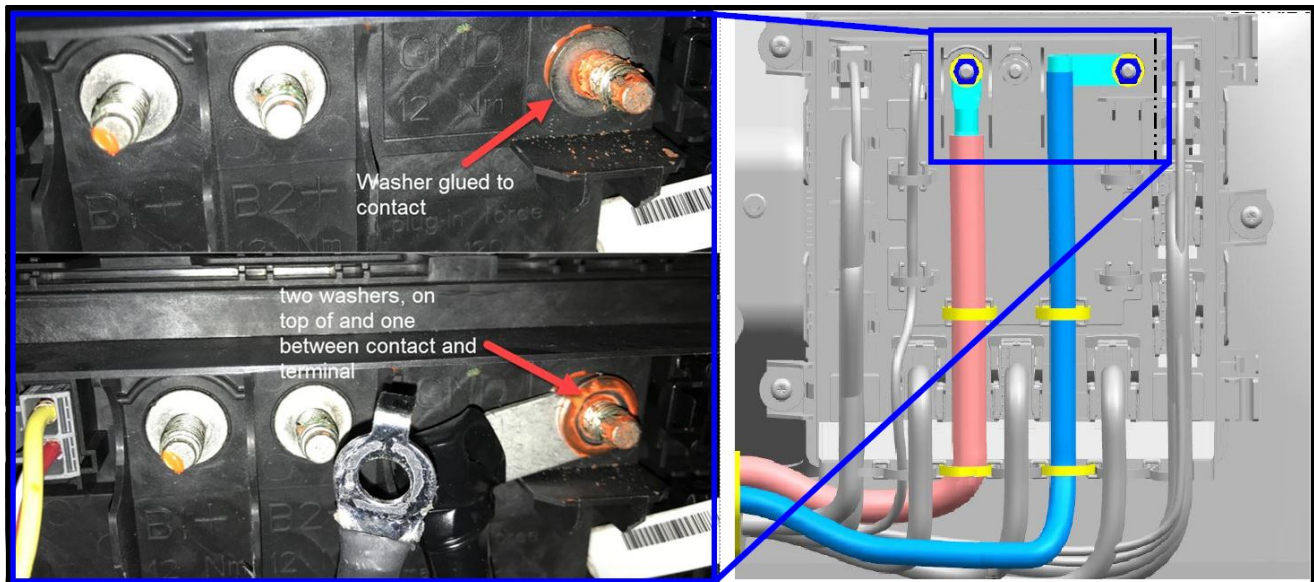
### Example of poor sSAM connections

Maintaining a good power and ground supply to the Single Signal Detect and Actuation Module (sSAM), is required for the sSAM to operate properly. Poor connections at supply wires to the sSAM can result in erratic operation of SSAM functions. See images of poor sSAM connections.
