MODEL
2019MY
Niro (DE HEV/PHEV)

NUMBER
211

TECHNICAL SERVICE BULLETIN

SUBJECT: AEW P PARTIAL REPLACEMENT FOR DTC P2600/P0C73

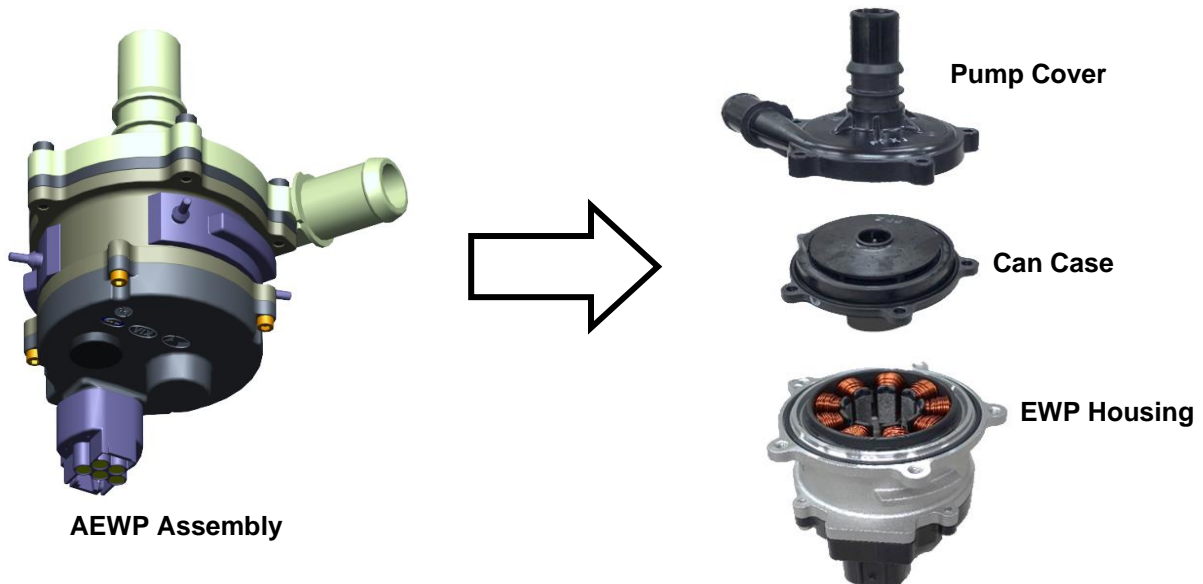
This bulletin provides information to replace the Can Case of the Auxiliary Electric Water Pump (AEWP) on some 2019MY Niro (DE HEV, DE PHEV) vehicles produced from November 26, 2018 through January 23, 2019, which may exhibit MIL 'ON' with DTC P2600 and/or P0C73. The vehicle may exhibit intermittently poor electric connection which may be caused by water inflow into the case due to poor sealing of the joint. Follow the procedure outlined in this publication to partially replace AEW P parts with the AEW P Kit parts listed in this bulletin. Before conducting the procedure, verify that the vehicle is included in the production range of affected vehicles.

DTC P2600: Coolant Pump "A" Control Circuit/Open
DTC P0C73: Motor Electronics Coolant Pump "A" Control Performance

NOTE: Only if the stator coil is found to be contaminated or the connector terminal is corroded, should the entire AEW P assembly be replaced. Coolant add cost should be claimed by sublet.

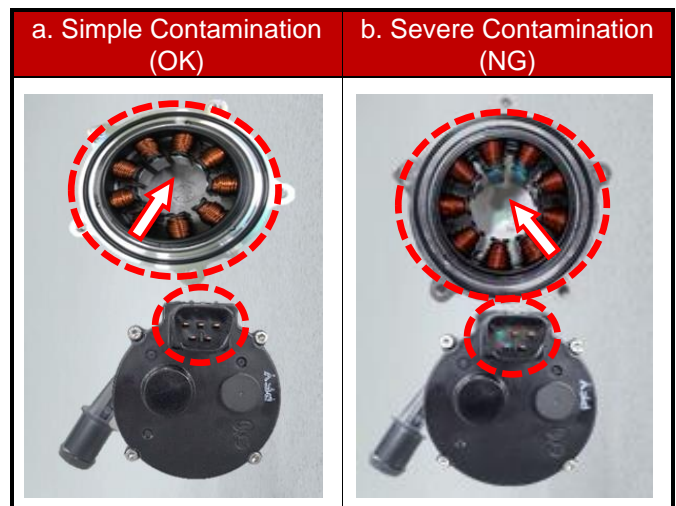
7. Check for coolant intrusion and terminal corrosion in the AEWP housing and take action according to the procedure and example photos.

- a. Simple contamination of the stator coil and power terminal:
Clean and dry the inside and replace the Kit parts (can case, S-ring, O-ring).
- b. Severe contamination of the stator coil and terminal:
Replace the AEWP assembly.

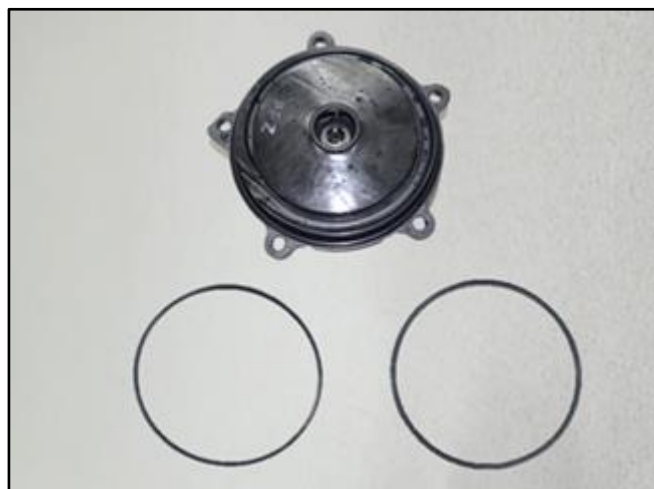
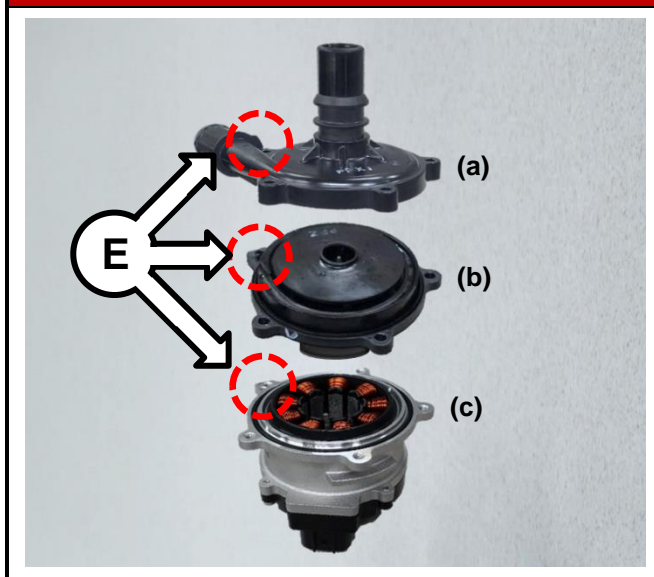
- Verify that O-ring is not stuck when assembling.
- Check assembly direction when assembling pump cover, can case, and housing. If center ball and holes do not align, the assembly will not fit correctly. (Refer to diagram at right.)

Fit "Center Ball" with "Hole" (E) when assembling Pump Cover (a) Can Case (b) and Housing (c).
