# Service Bulletin

Bulletin No.: 17-NA-336

**Subject:** Rear Fascia Gap

Brand:	Model:	Model Year:		VIN:		Engine:	Transmission:
		from	to	from	to		
Chevrolet	Camaro	2016	2021	—		All	All

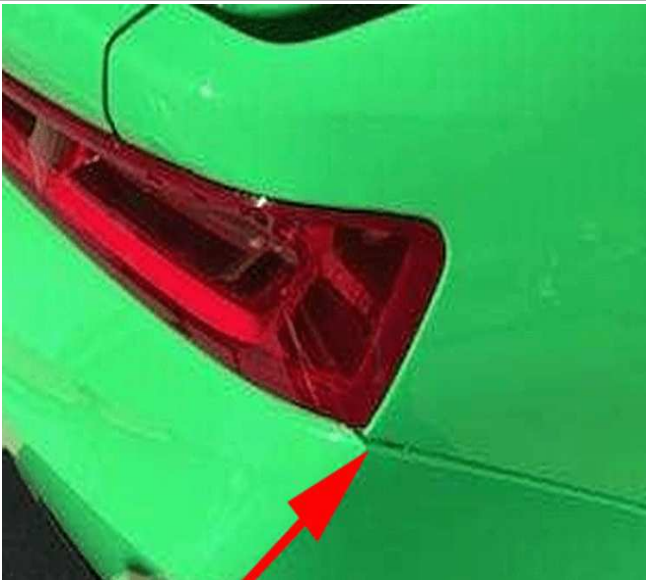
4882654

<p>4882655</p> <p>4882657</p>	
Cause	Some customers may comment that the rear fascia is sticking out near the tail lamp. This may be due to the stud not being centered in the hole of the impact beam mounting plate.
Correction	Loosen the nuts to the impact beam and re-adjust using the Service Procedure outlined below.
