Service Bulletin

Bulletin No.: 18-NA-135

Subject: Water Leaks in Bed Area on Trucks Equipped with High Desert Package

Brand:	Model:	Model Year:		Date Breakpoint:		Engine:	Transmission:
		from	to	from	to		
Chevrolet	Silverado	2017	2018	SOP	Built Prior to March, 1, 2018	All	All

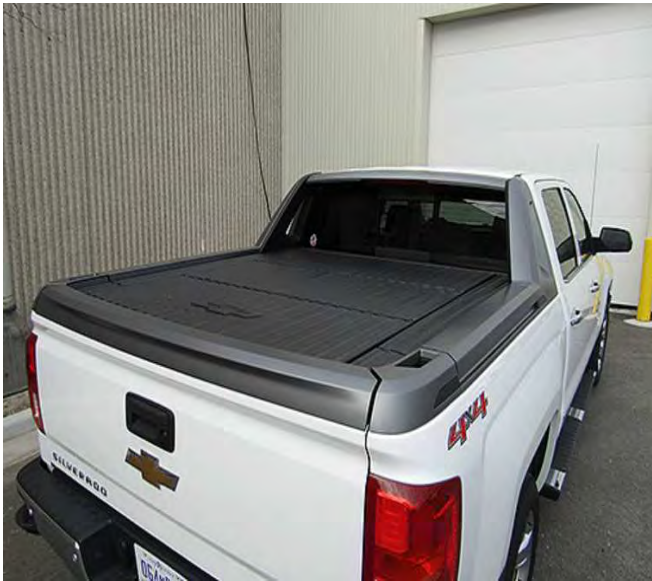
</div> <p>5048683</p> <p>Some customers may comment on finding water leaks in the bed area of their vehicle, which has the High Desert option package.</p>
Cause	The cause of the condition may be that the design intent of the High Desert Package is NOT to provide a completely water tight cargo area. The package is designed to have a water management system, but some water may still migrate into the bed area.
Correction	A design improvement has been made to all of the service parts listed in the part table below. Follow the Service Procedure below for part replacement and additional steps that can reduce, but not eliminate, water getting into the bed area.
