Service Bulletin

Bulletin No.: 20-NA-105

Subject: 360 Camera Views go Blank with Tailgate Removed

Brand:	Model:	Model Year:		VIN:		Engine:	Transmission:
		from	to	from	to		
Chevrolet	Silverado 2500HD/ 3500HD	2020	2021			All	All
GMC	Sierra 2500HD/ 3500HD	2020	2021

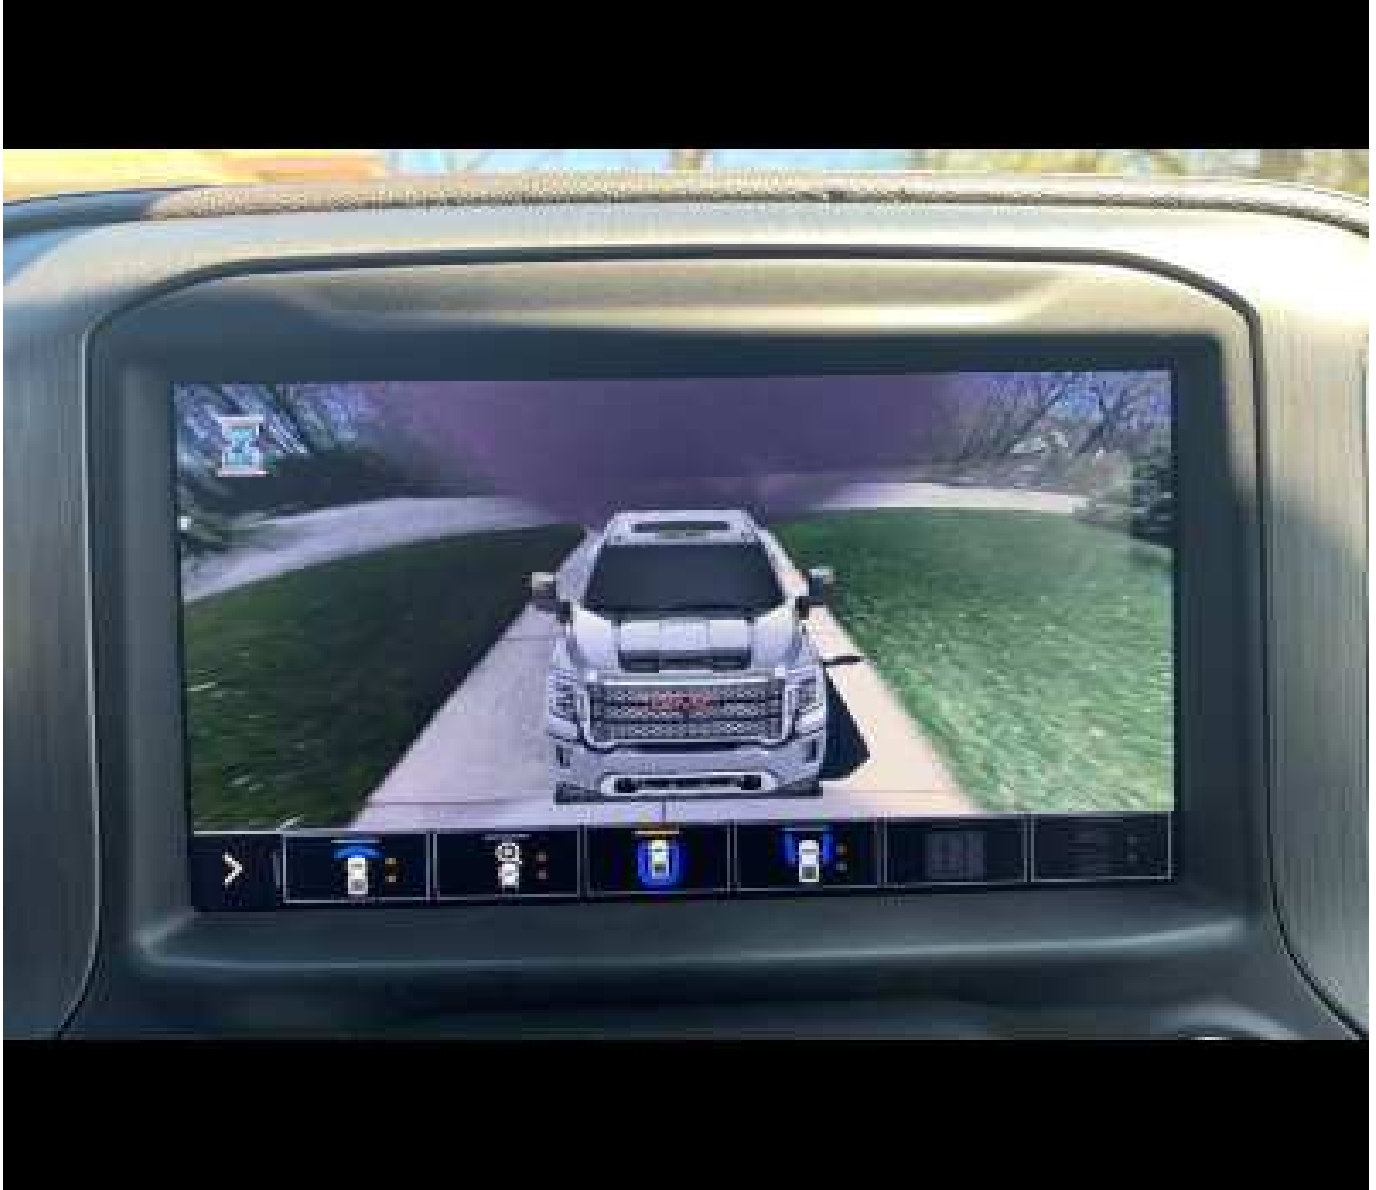
Frontend view, Tailgate removed

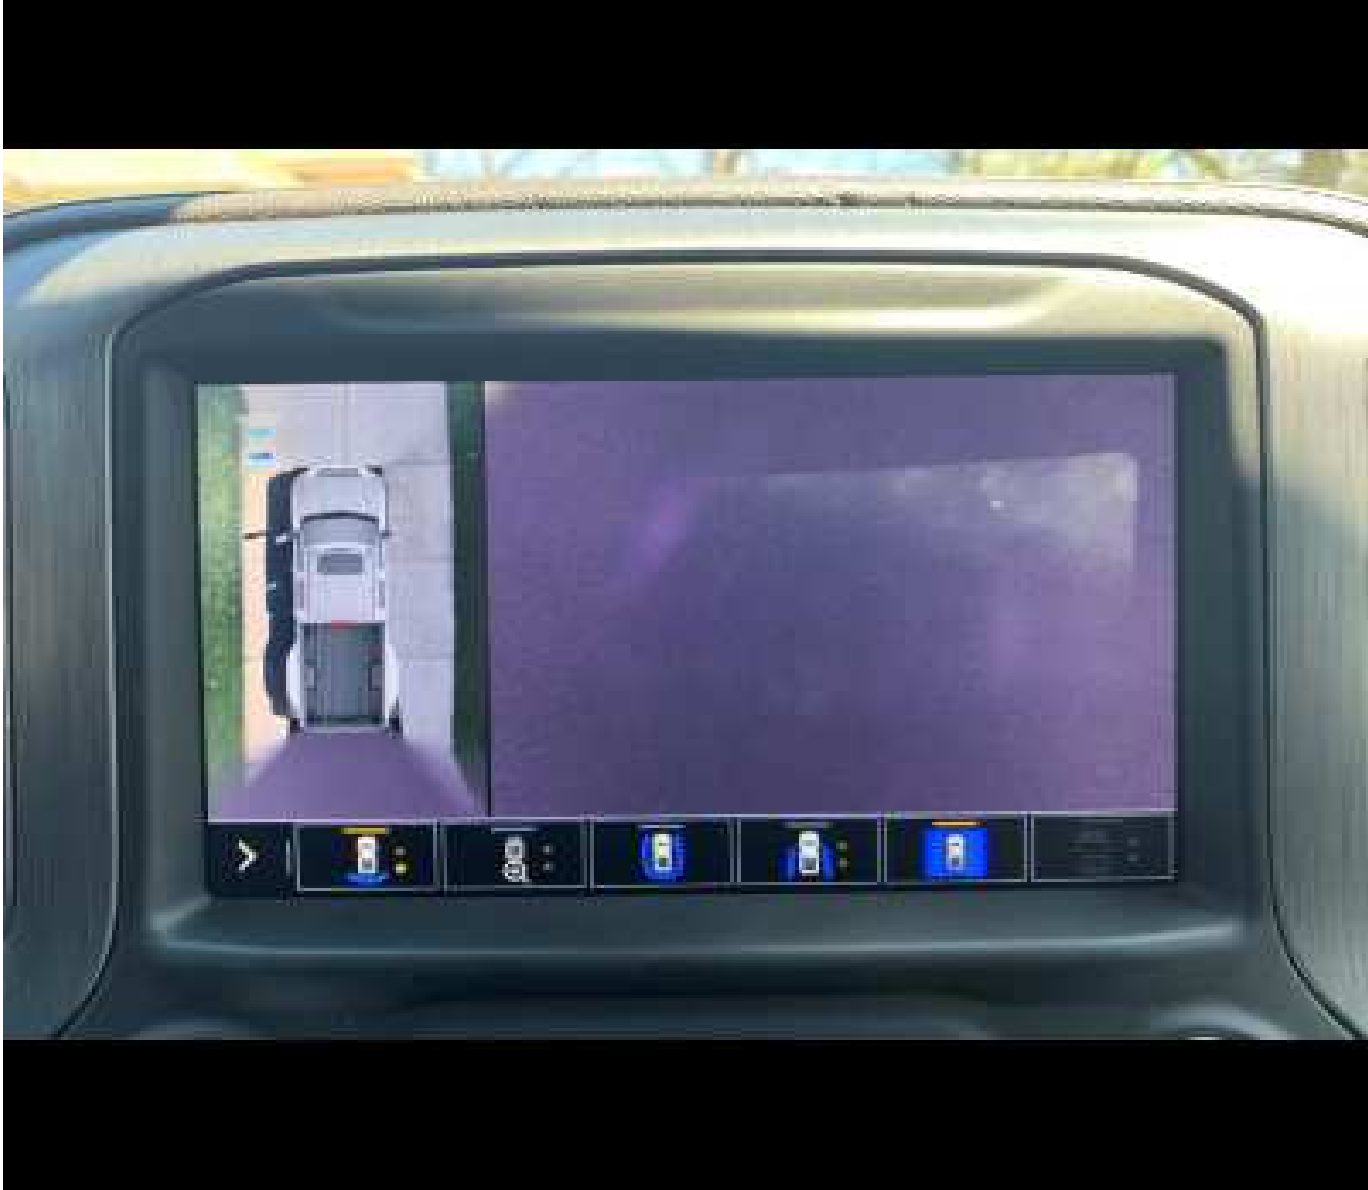
Tailgate backup camera, Tailgate removed

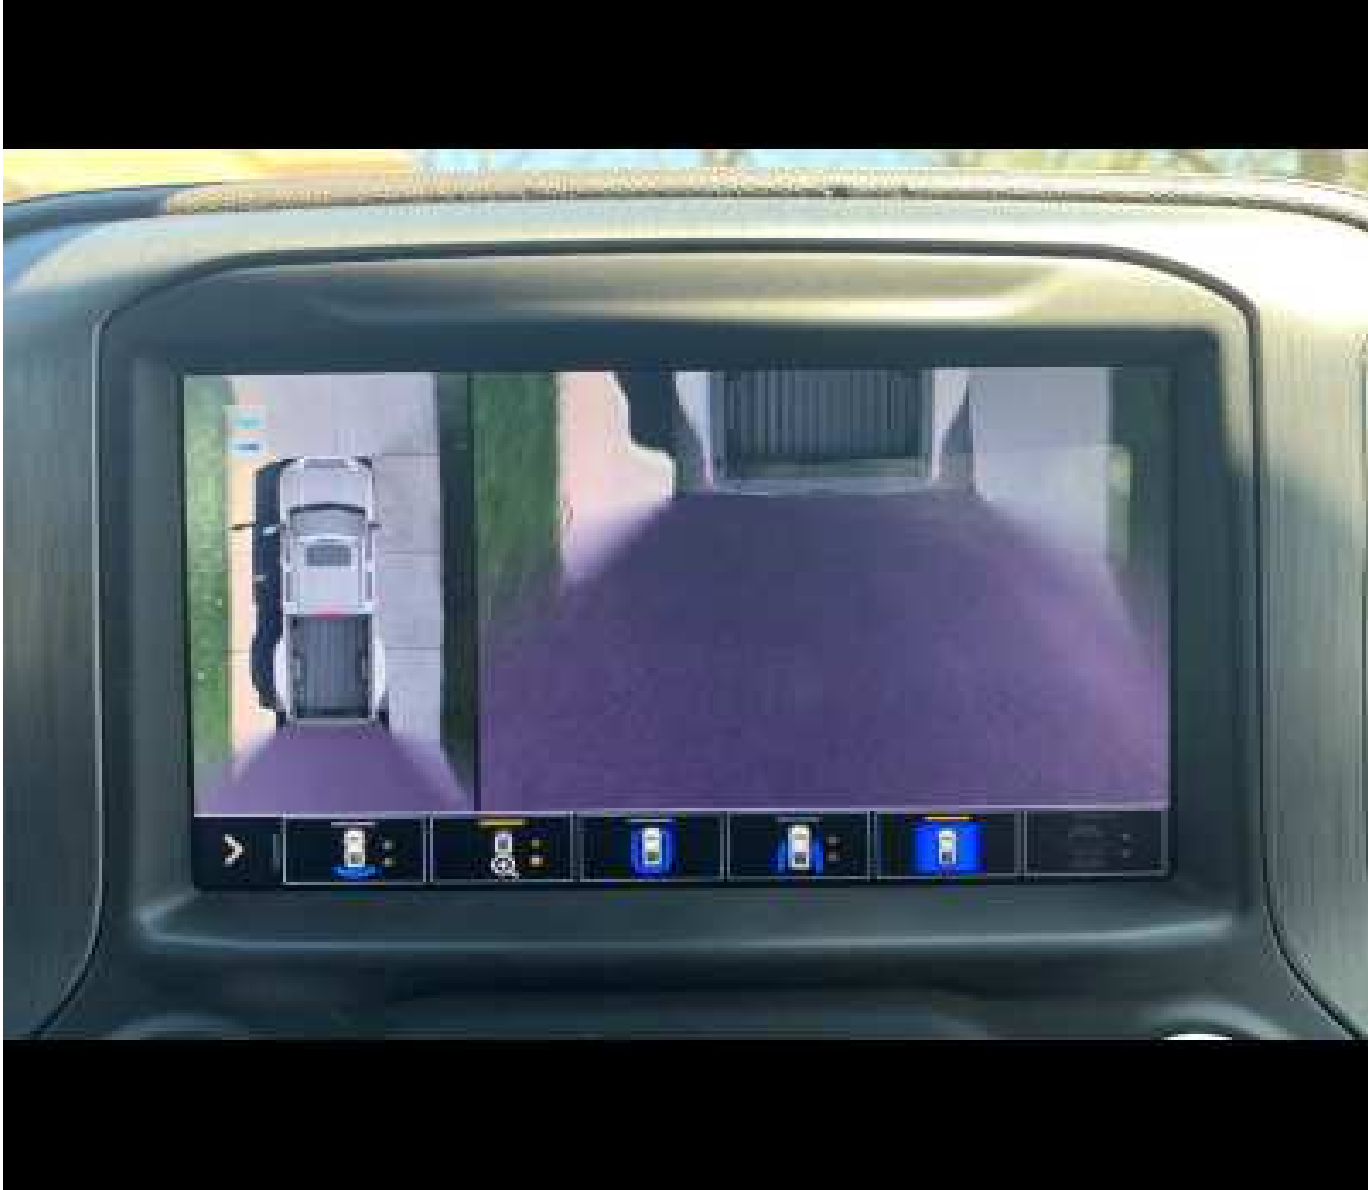
Tailgate overhead camera, Tailgate removed

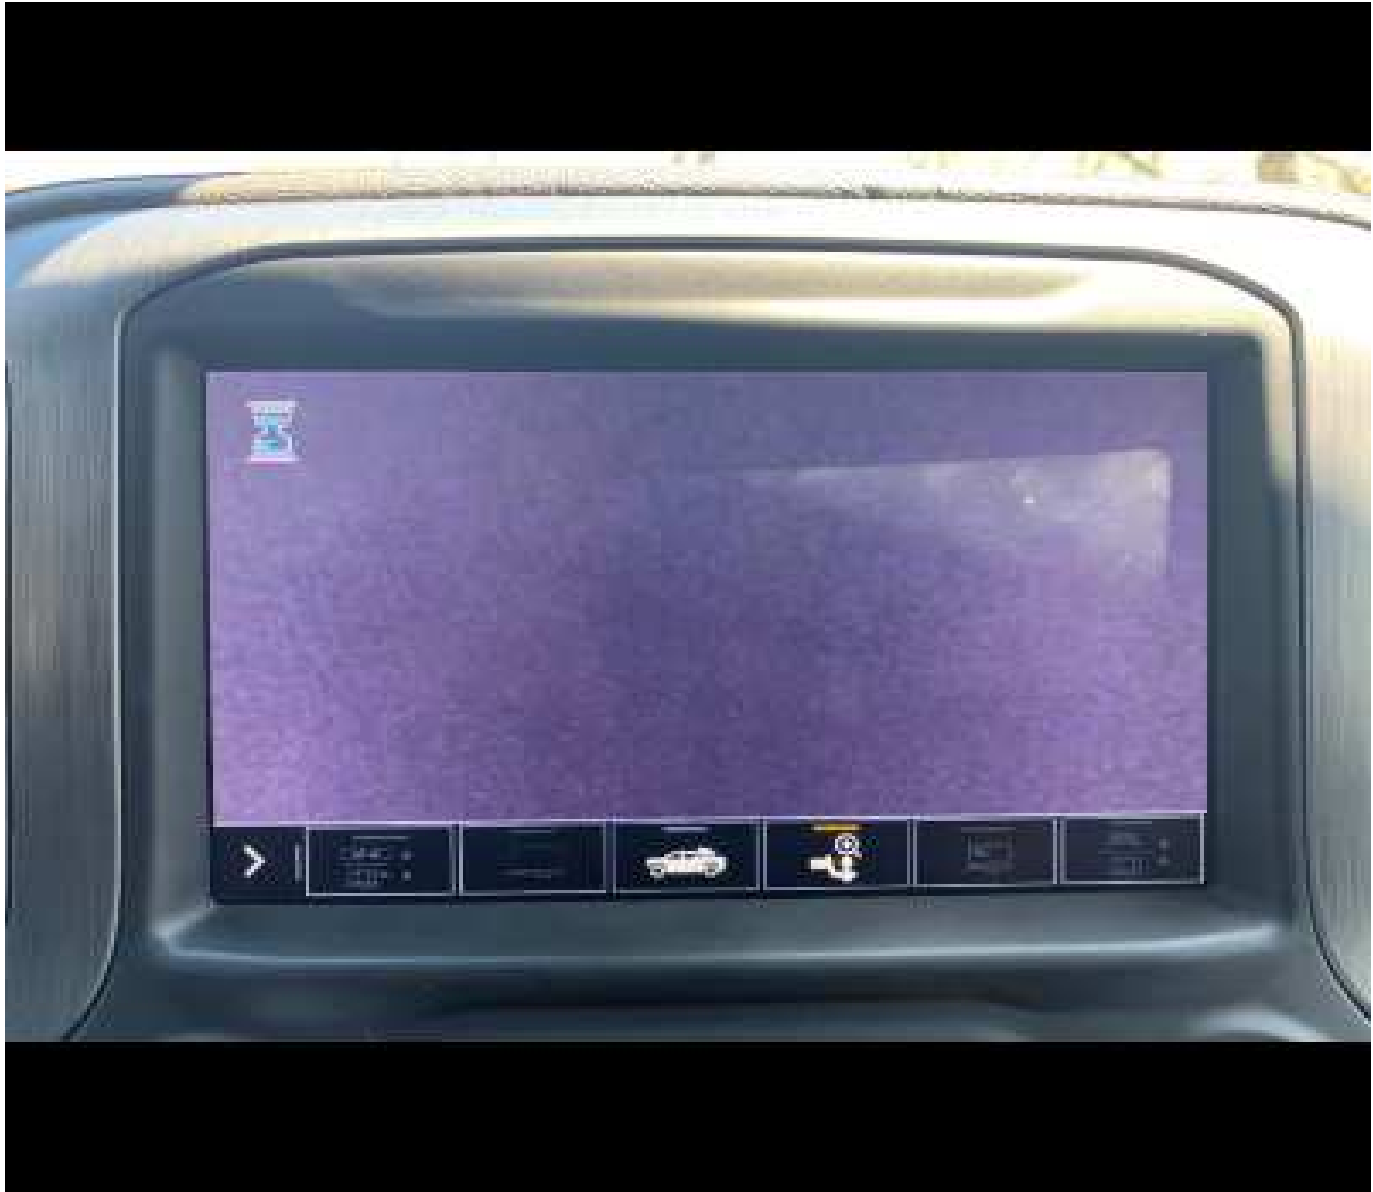
Trailer hitch camera, Tailgate removed
