# Service Bulletin

Bulletin No.: 20-NA-142

Date: January, 2021

**Subject: Shudder/Surging While Driving**

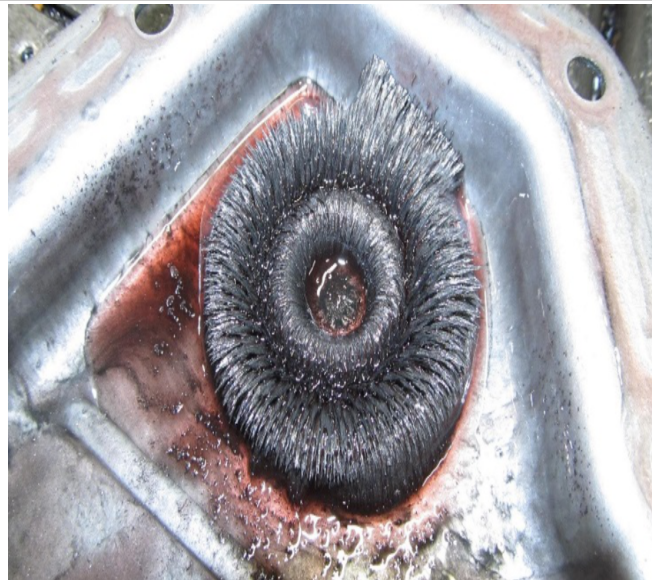
5360216

<b>Involved Region or Country</b>	North America, Russia, Middle East, Israel, Palestine, Chile, Columbia, Ecuador, Paraguay, Peru and Thailand.
<b>Condition</b>	Some customers may comment that a surging condition is felt when driving. Some technicians may find during diagnosis or performing PIP5504F, may identify the surging as a torque converter shudder.
<b>Cause</b>	This condition may be caused by additives in the transmission fluid may have been depleted during vehicle operation. – Some of these additives assisted with regulating a consistent slip rate of the clutches.
<b>Correction</b>	<ol style="list-style-type: none"> <li>1. Raise the vehicle.</li> <li>2. Remove the transmission pan.</li> </ol>

- If metallic debris is present remove transmission and replace torque converter, replace filter. Refer to *Torque Converter Replacement* in SI.
- If metallic debris is not present replace the transmission filter, reinstall transmission oil pan and perform the steps in the Service Procedure below.
