Service Bulletin

Bulletin No.: 21-NA-013

Subject: Rattle or Ticking Noise Heard Coming from B-Pillar Area

Brand:	Model:	Model Year:		Date Breakpoint:		Engine:	Transmission:
		from	to	from	to		
GMC	Terrain	2020	2020	SOP	June 1, 2020	All	All

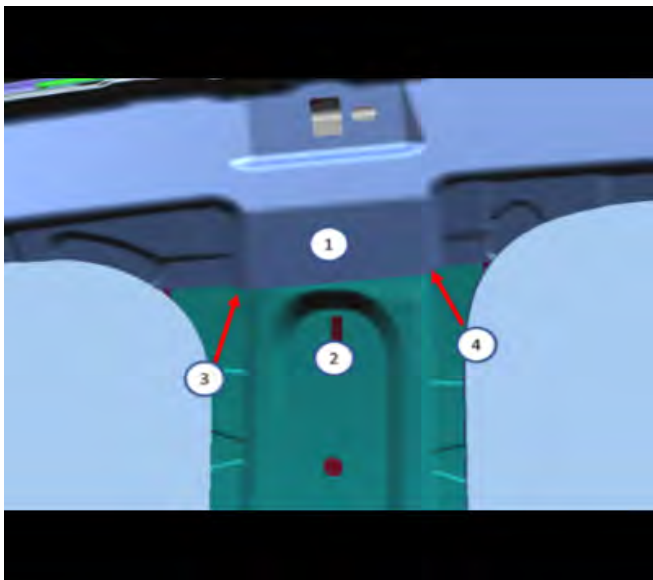
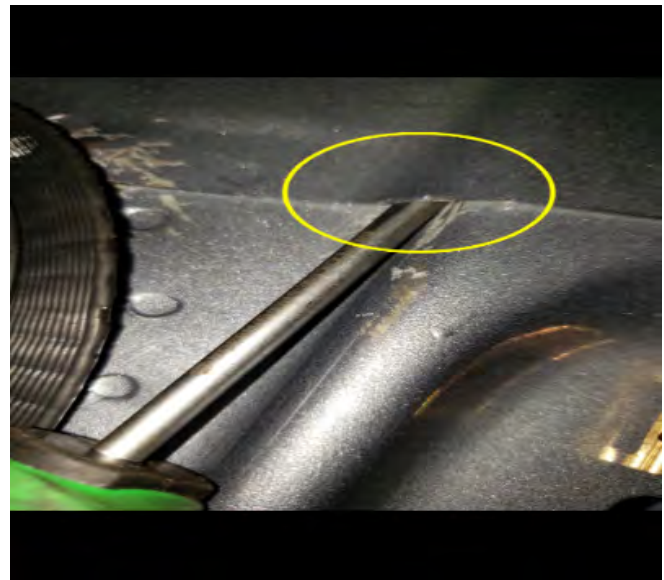
2. Locate the sheet metal area at the top of the B-Pillar, shown in the graphic above
3. Locate the gaps in the sheet metal, #3 and #4.

Important: The screwdriver should be large enough to fill the gap, to be effective.

4. Carefully insert and wedge a screwdriver into the two gaps.
 - If the noise is NOT eliminated, DO NOT complete the repair below, but continue with further SI diagnostics to pinpoint the cause.
 - If the noise IS eliminated, continue to step #5 and complete this repair.
