Service Bulletin

Bulletin No.: 21-NA-014

Subject: Intermittent Malfunction Indicator Lamp (MIL) Illuminated - DTC P146F Set

Brand:	Model:	Model Year:		VIN:		Engine:	Transmission:
		from	to	from	to		
Buick	Encore GX	2020	2020			LIH	
Chevrolet	Trailblazer (Vin M)	2021	2021

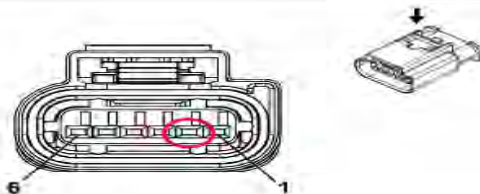
5710159

2. Measure the resistance drop from G58: Evaporative Emission Purge Pump terminal 2, to the negative terminal at the battery.
 - Resistance as high as a 2.3Ω was found on ckt 580 from terminal 2 of the G58 Emission Purge Pump to Battery negative post, (.11 mV drop.)
3. Cut the circuit 580 (BK/GN) approximately 2" back from the G58 Emission Purge Pump electrical connector.
