Model Series 167 - Offset Seat Backrest In Second Seat Row

Topic number	LI91.12-P-072068
Version	1
Function group	91.12 Rear seats
Date	12-18-2020
Validity	V/X 167 low lock code 567 (Rear seats, electrically adjustable)
Reason for change	
Reason for block

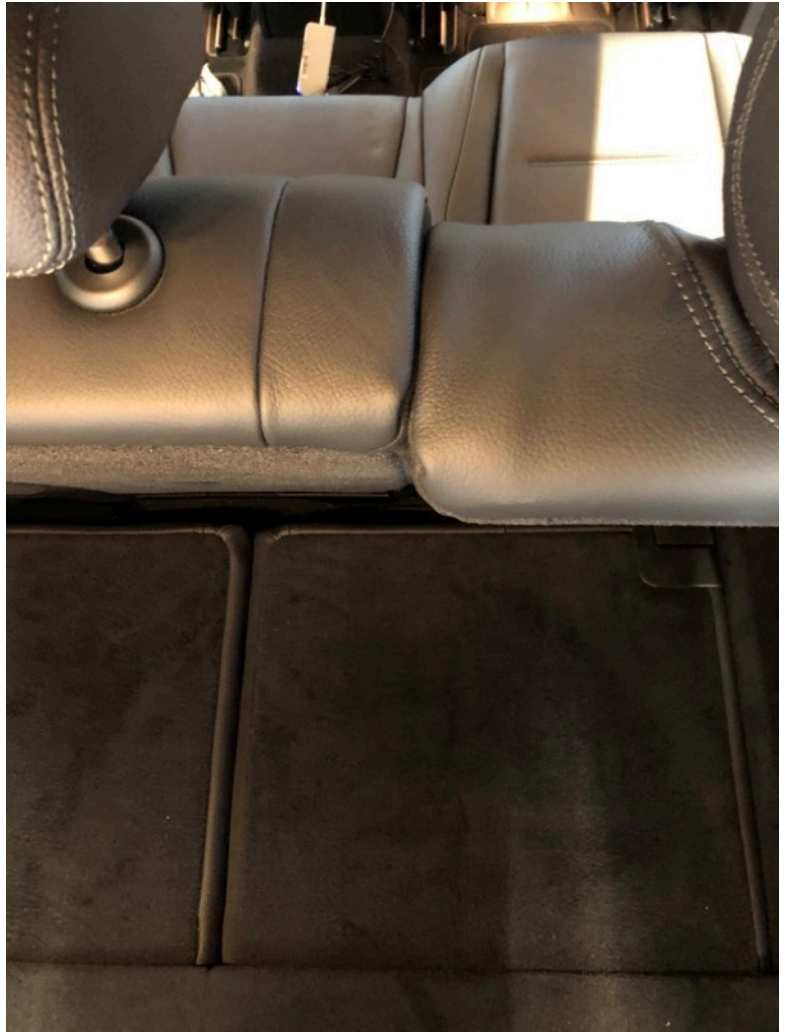
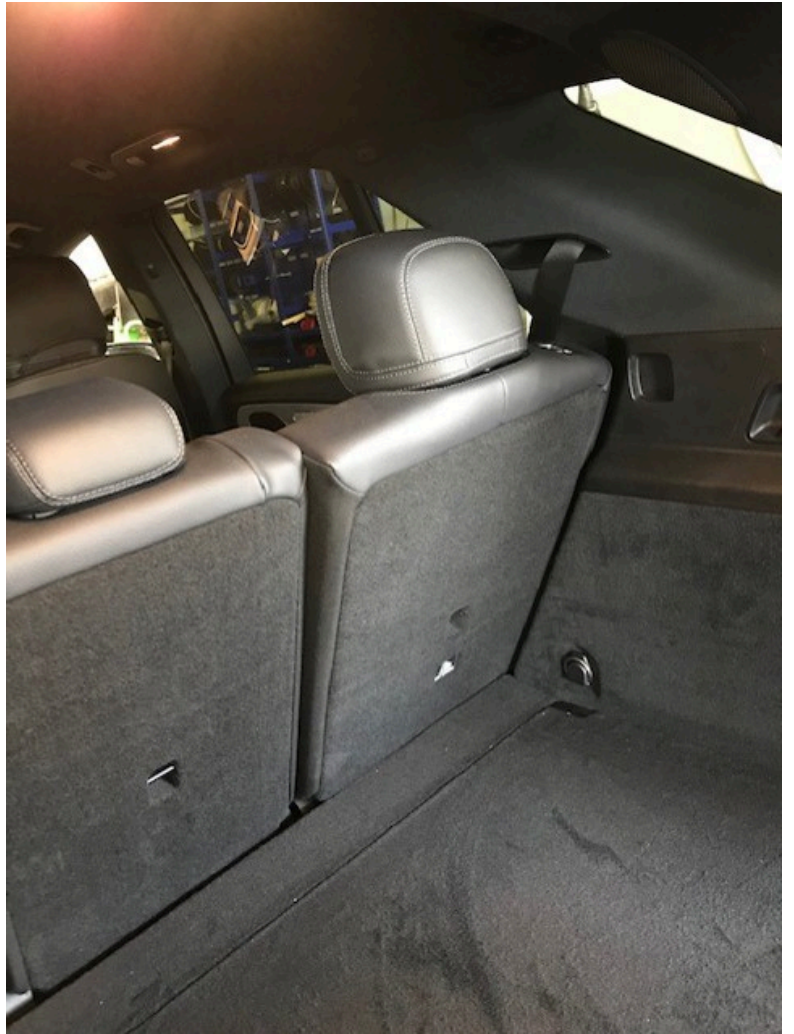
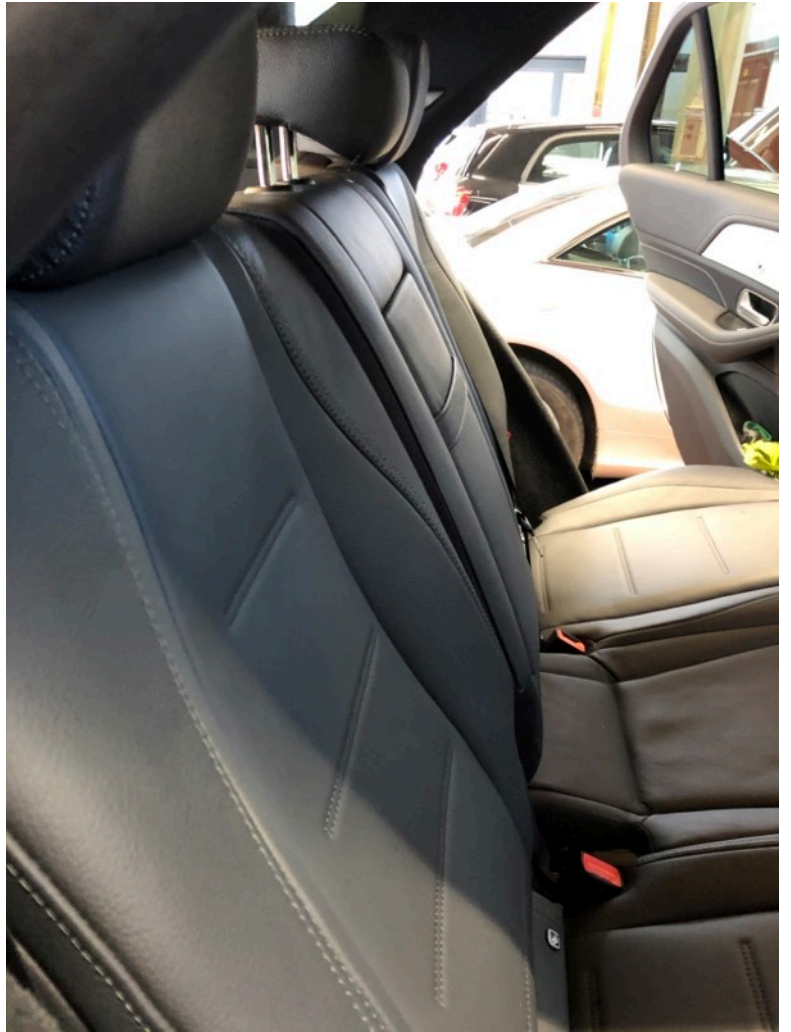
The backrests of the second seat row (60% and 40% side) are offset relative to each other.

- Supplier has failed to carry out adjustment
- Accumulation of tolerances

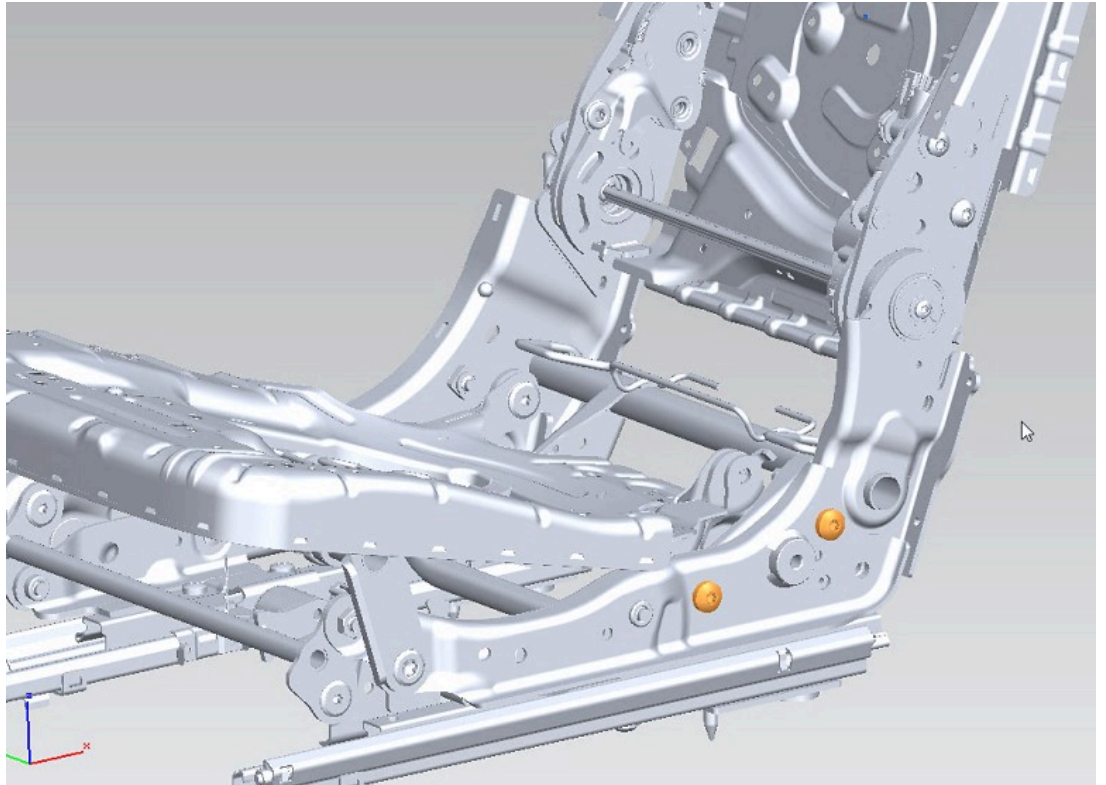
pic.7.jpg:

****NOTE**** As a result of optimization measures, it is possible that new seat structures on the 40% side may only have 2 screws instead of 3 (pic.7).
