**Symptom in Vehicle Interior - Water Noise (Sloshing) During Acceleration/Braking or Water Leaking Into Rear Footwell (224/20)**

Model Line: **Taycan (Y1A)**

Model Year: **As of 2020 up to 2021**

Concerns: **Water drains on the high-voltage battery protective plate**

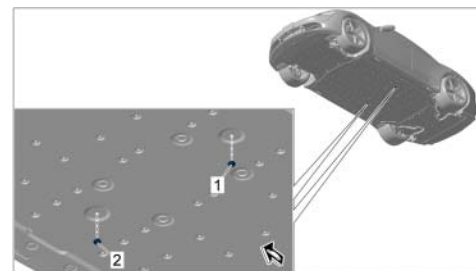
*Water drain on protective plate*

Cause: Dirt particles can cause the water drains on the high-voltage battery protective plate to become blocked and result in water not draining away.

Work Procedure: 1 Remove both water drains ⇒ *Water drain on protective plate -1-* and ⇒ *Water drain on protective plate -2-* from the high-voltage battery protective plate using a suitable tool.
