Complaint - Front Seat Ventilation Does Not Function: Observe Specified Procedure (223/20)

Model Line: **Taycan (Y1A)**

Model Year: **As of 2020**

Concerns: **Front seat ventilation**

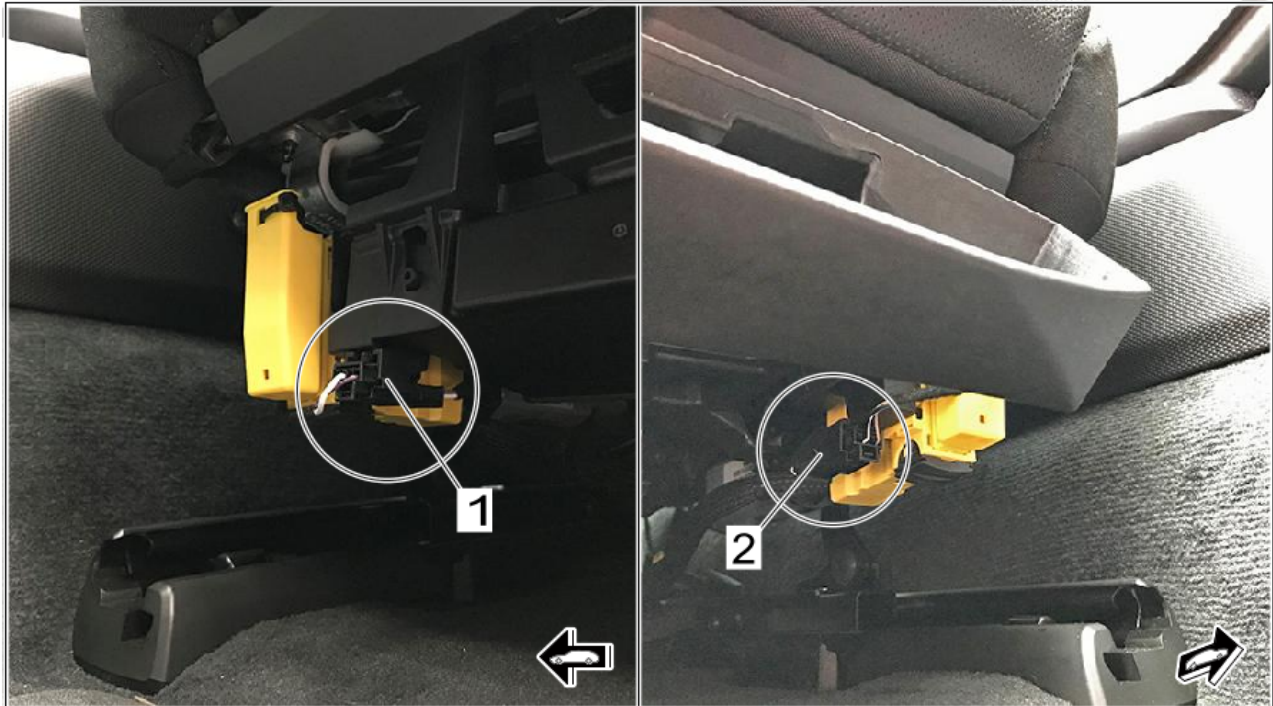
Plug connections for front seat ventilation

Information: Seat ventilation on driver side and/or passenger side does not function.
This may be due to a disconnected electric plug connection on the seat ventilation system, which is unlocked when the seat is moved. Contact is then interrupted in the electric plug connection.

- 1 – Plug connection for front seat ventilation on driver side
- 2 – Plug connection for front seat ventilation on passenger side

Action required: Connect and lock electric plug connections for front seat ventilation as well as securing them with a tie-wrap.
