GROUP ELE	MODEL 2021MY K5 (DL3a) Sorento (MQ4) and Hybrid (MQ4 HEV)
	NUMBER 229 (Rev 1, 02/04/2021)	DATE January 2021

TECHNICAL SERVICE BULLETIN

COMBINATION TSB / SERVICE ACTION: DISPLAY AUDIO 2.0 SOFTWARE UPDATE FOR WIRELESS CARPLAY ISSUE (SA460)

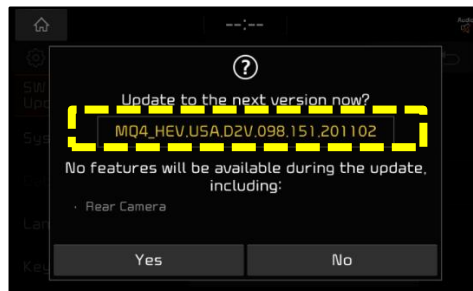
This bulletin provides the procedure to update the head unit software on some 2021MY K5 (DL3a), Sorento (MQ4a), and Sorento Hybrid (MQ4 HEV) vehicles equipped with a Display Audio 2.0 head unit, which may exhibit a wireless CarPlay connectivity issue with Apple phones running iOS14 software version. To correct this concern, perform the head unit software update procedure outlined in this bulletin to the vehicles in dealer stock and customer vehicles. Once the update is performed on the head unit, please follow the instructions 'For Customer' at the end of the procedure in this bulletin.
