Ferrari North America

Technical Information

Date: February 2021
Bulletin #: 2728
Campaign #: 464
Supersedes:
Section: 9

Subject: Exhaust Terminal Grills Replacement

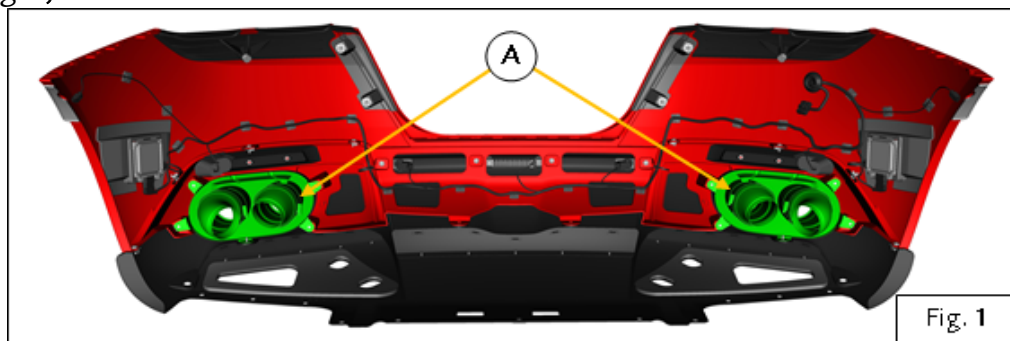
- Remove the rear bumper (as described in paragraph E3.05 of the **Workshop Manual**).
- The exhaust terminal grills (A) are highlighted in **green** on the inside of the rear bumper – Fig.1;
