MODEL  
2019-2020MY  
Niro (DE HEV/PHEV)

NUMBER  
093

## TECHNICAL SERVICE BULLETIN

**SUBJECT: 6-SPEED DCT SHIFT IMPACT/NOISE INSPECTION  
AND OIL REPLACEMENT**

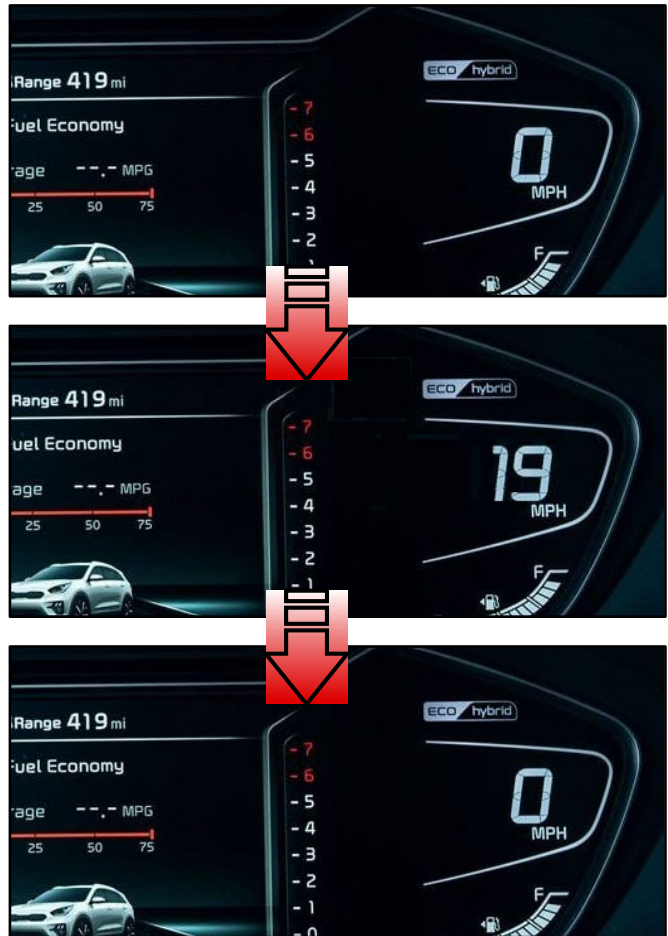
1. With the vehicle fully stopped, press the accelerator pedal (over 60% of Accelerator Position Sensor [APS]) to 19MPH, then decelerate to 0MPH.

- Perform this step more than **25 times**, checking for DCT noise and shift impact **each time** when accelerating.
- Conduct the inspection on roads or other areas with no traffic, or as little traffic as possible.

- 2a. If there is no noise or shift impact detected, use KDS to check for DTC(s). No further work is necessary.
- 2b. If any noise or a noticeable shift “shock”, “clunk” or other abnormal symptom is present, proceed with the ‘DCT Oil Replacement’ outlined on page 3.
