Spare Parts Requirements for High-Voltage Components - Check and Update Software as Necessary (20/21)

Vehicle Type: **Taycan (Y1A)**

Model Year: **2021**

Equipment: Vehicles with M-no. S1G (Control system deployment, VR version 4)

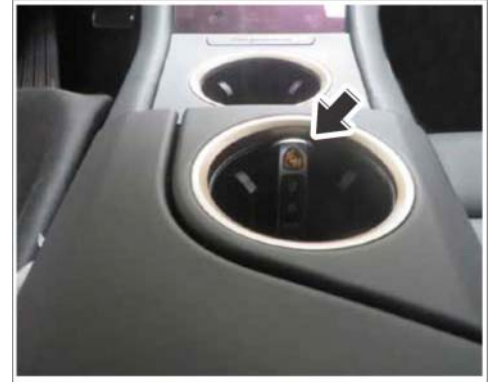
Emergency start tray

- 3 Position the **driver's key** with the back facing forward upright between the holding struts in the rear cupholder (**emergency start tray**) to guarantee a permanent radio link between the vehicle and remote control ⇒ *Emergency start tray -Arrow-*.

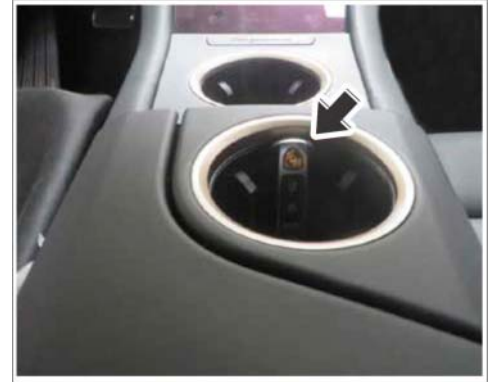
Emergency start tray

- 3 Position the **driver's key** with the back facing forward upright between the holding struts in the rear cupholder (**emergency start tray**) to guarantee a permanent radio link between the vehicle and remote control ⇒ *Emergency start tray -Arrow-*.

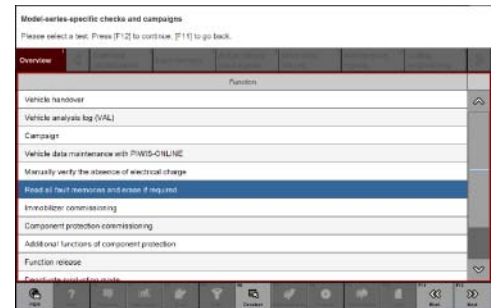
Erasing fault memories

- 3.2 Select the function "Read all fault memories and erase if required" and press •F12“ ('Next') to confirm your selection ⇒ *Erasing fault memories*.

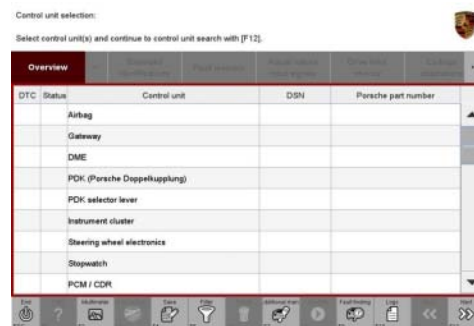
Control unit selection

3.6 Once you have erased the fault memories, select the **'Overview'** menu to return to the control unit selection screen ⇒ *Control unit selection*.
