SIL 780

Service Information Letter

Units Affected: Model year 2017-2020 chassis equipped with the EZ Trac AWD system (Verify that your unit is affected by reviewing the attached list in this SIL or by accessing your fleet on connect.altec.com/login)

EZ Trac AWD System Inspection

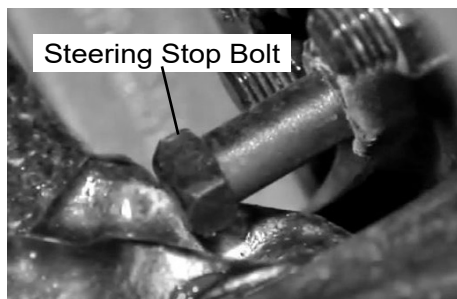
Figure 1 – Inspecting Stop Bolt

1. Position the unit on a level surface. Apply the parking brake and chock the wheels. Turn off the engine.
2. Get under the front of the chassis on a mechanic's creeper.
3. Visually inspect the steering stop bolts to see if they are bent or otherwise damaged (refer to Figure 1).

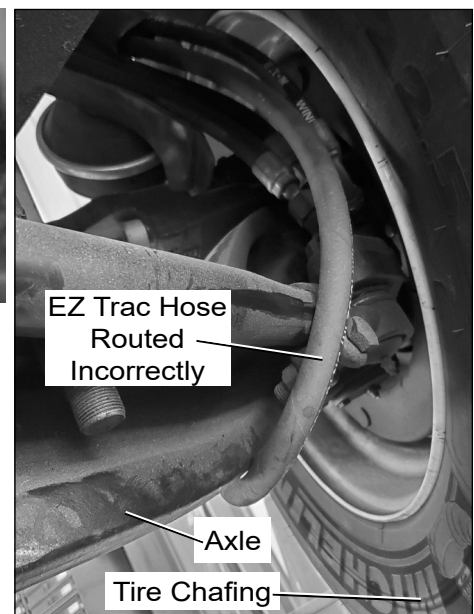
Figure 2 – Inspecting Tire and Hose

4. Visually inspect the inside of the front tires for any signs of rubbing or chafing on chassis components (refer to Figure 2).

5. Visually inspect the EZ Trac hydraulic hoses for any signs of rubbing, chafing, or leaks. Also inspect the EZ Trac hoses for routing that goes under any axle or suspension components or routing that could otherwise cause potential wear or snagging of the hoses (refer to Figure 2).

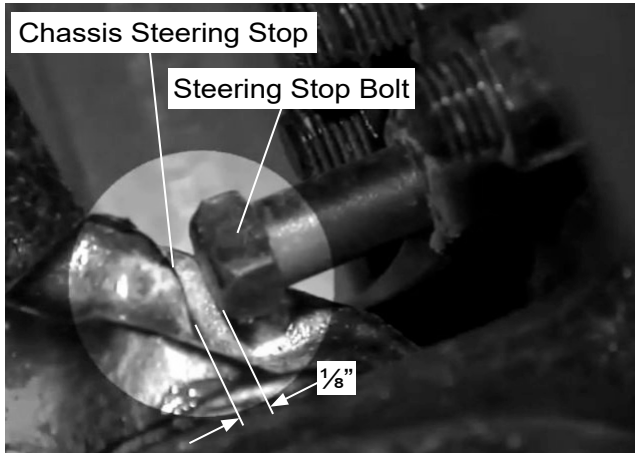
Figure 3 – Proper Stop Bolt Clearance

- Check whether the inside of the tire contacts any chassis components or is close enough it could make contact during suspension movement.
- Check whether the steering stop bolts have the proper clearance of $\frac{1}{8}$ " from the chassis steering stops as shown in Figure 3, if they have more or less than $\frac{1}{8}$ " clearance, or if they are hitting the steering stops as shown in Figure 4.

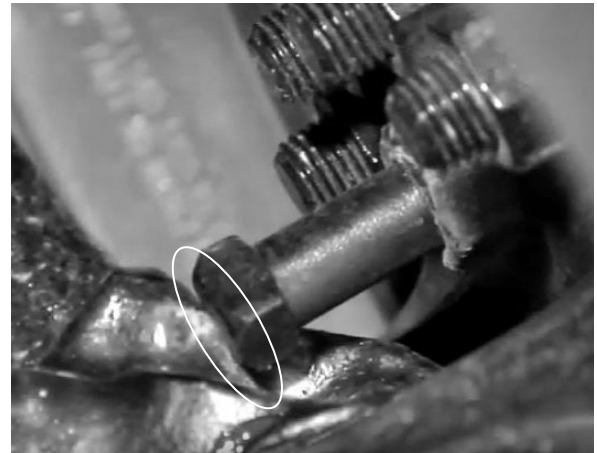
Figure 4 – Stop Bolt Hitting

Altec has discovered that the EZ Trac hydraulic all-wheel drive (AWD) system may have been improperly installed on some units. Incorrect steering adjustments can cause the front wheels to oversteer. This can damage the steering stop bolts, causing the tires to rub on chassis components. Incorrect hydraulic hose routing can subject the hoses to damage. This can cause fluid leakage, resulting in the loss of AWD assistance.

- For a unit with a TRW steering gearbox, call 1-877-GO ALTEC (1-877-462-5832) to schedule to have the unit repaired at an Altec facility, and state that the unit has a TRW steering gearbox. Also describe the inspection concerns that were found. Take the unit out of service until the repair is completed. Do not complete the Inspection Sheet at the end of this SIL.

- For a unit with a Shepherd steering gearbox, call 1-877-GO ALTEC (1-877-462-5832) to schedule to have the unit repaired at an Altec facility, and state that the unit has a Shepherd steering gearbox. Also describe the inspection concerns that were found, including whether or not the steering stop bolts are damaged. Take the unit out of service until the repair is completed. Do not complete the Inspection Sheet at the end of this SIL.

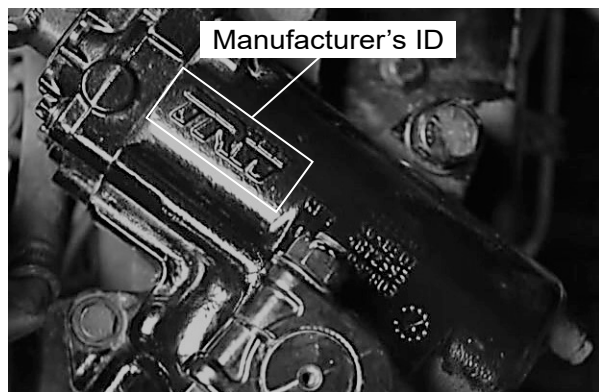
Figure 5 – TRW Steering Gearbox

- If there are concerns with any of the inspected components or clearances, determine if the chassis has a TRW steering gearbox or a Shepherd steering gearbox by looking for the manufacturer's name on the gearbox housing (refer to Figures 5 and 6). Then proceed as described below.
