## Technical Service Bulletin

**Subject:** Heat Pan Clearance

**Applies To:** All Rosenbauer and Commercial Chassis with a Diesel Particle Filter/Selective Catalytic Reduction system.

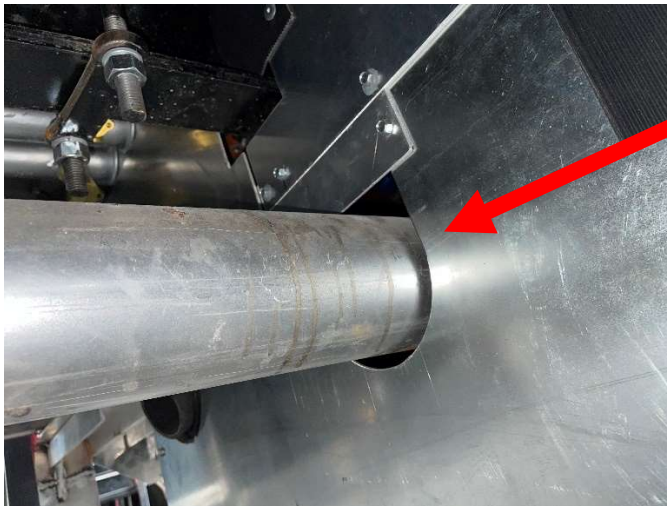
1" MINIMUM GAP AROUND THE  
EXHAUST PIPE

3/4" MINIMUM GAP AROUND THE  
ENTIRE DRIVELINE AND ALL OF ITS  
COMPONENTS

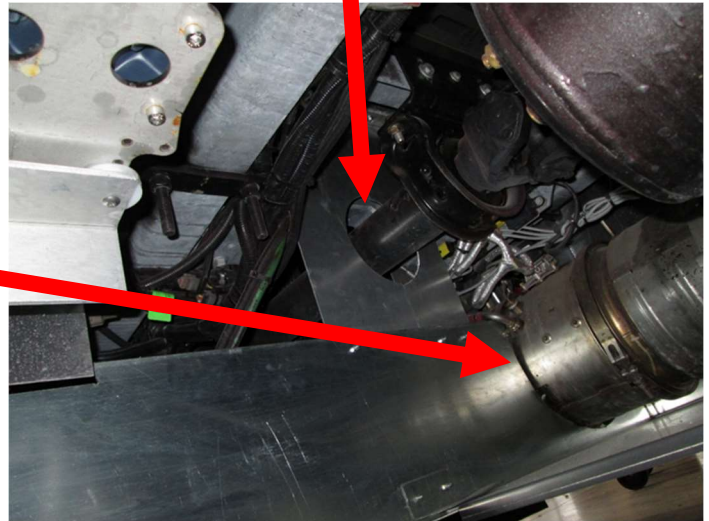
1" MINIMUM GAP ALL THE WAY  
AROUND THE AFTERTREATMENT
