N554 UPS2721-1BNAS1

# TECHNICAL BULLETIN

Update Prior to Sale: Air Conditioning (A/C) Compressor Bolts Incorrectly Torqued

MODEL:	MODEL YEAR:	VIN:
Range Rover Velar (LY)	2021	297299-302515

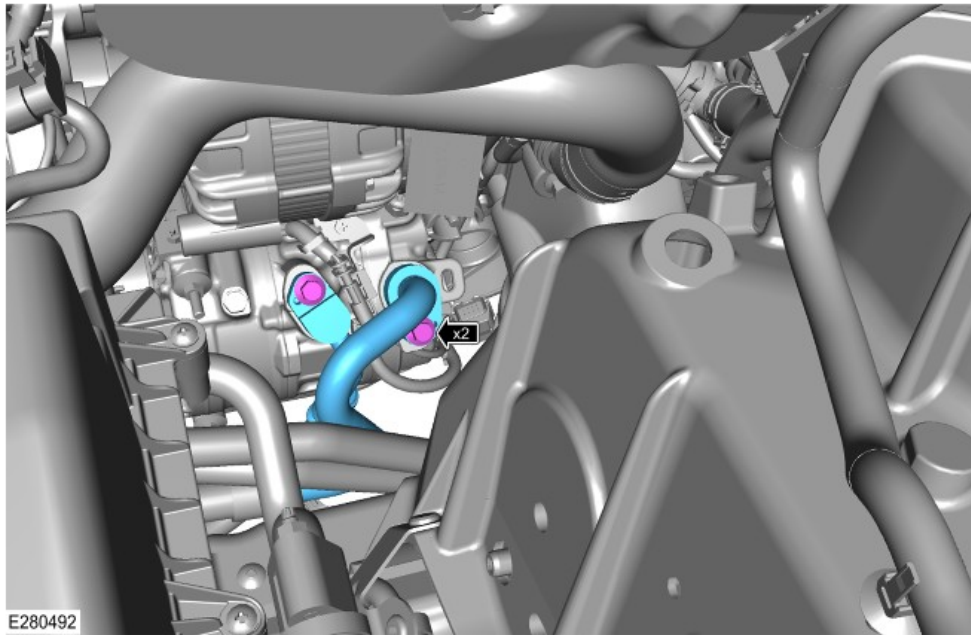
7. ■

An issue has been identified on certain Land Rover vehicles within the listed Affected Vehicle Range where the torque setting for the Air Conditioning (A/C) pipes-to-compressor joints was incorrectly set at 9 Nm and not the required torque value of 19 Nm.

With the coolant expansion tank repositioned for access, tighten the A/C pipe bolts.

- Torque: 19 Nm
