SIL 794

# Service Information Letter

Units Affected: AT37-G and AT40-G aerial devices built between 2016 and 2018 and mounted on a Ford F550 60" CA chassis (Verify that your unit serial number is affected by reviewing the attached list in this SIL or by accessing your fleet on [connect.altec.com/login](https://connect.altec.com/login))

## Rear Shear Plate Fastener Inspection

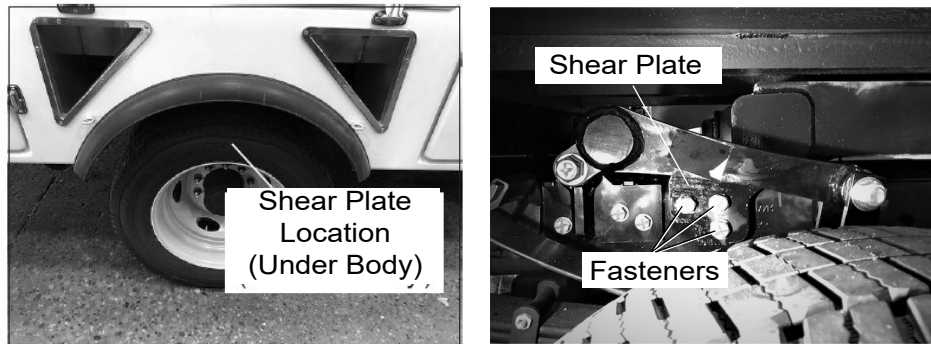
**Figure 1 — Shear Plate Location**

1. Position the unit on a level surface, apply the parking brake and chock the wheels.
2. Locate the rear shear plates on both sides of the subbase, visible inside the rear wheel wells (refer to Figure 1).

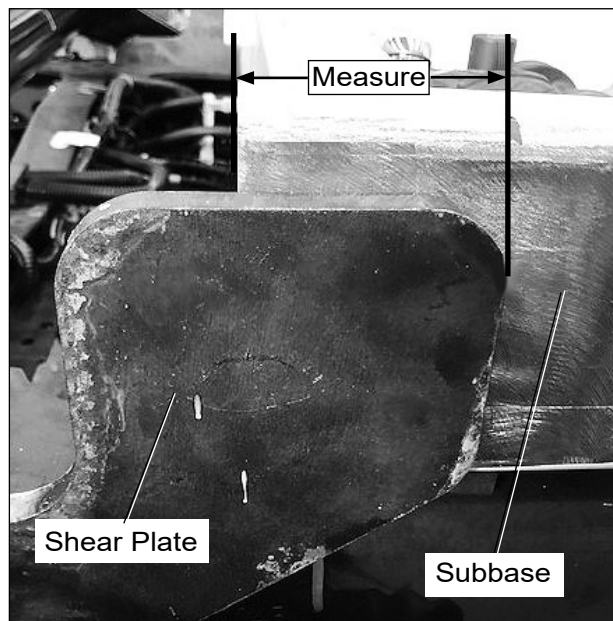
**Figure 2 — Measuring Shear Plate Position**

3. Measure the distance from the rear of the subbase to the front of the shear plate (refer to Figure 2) on both the curb side and street side of the chassis.
  - If the distance is between 2" and 4" proceed to step 4.
  - If the distance is greater than 4", call 1-877-GO ALTEC (1-877-462-5832) to order the Plug Kit, p/n 991251493 (includes parts for both sides), and schedule the installation to be completed within 30 days of the inspection. Do not complete the Evaluation Sheet at the end of the SIL. Proceed to step 6.

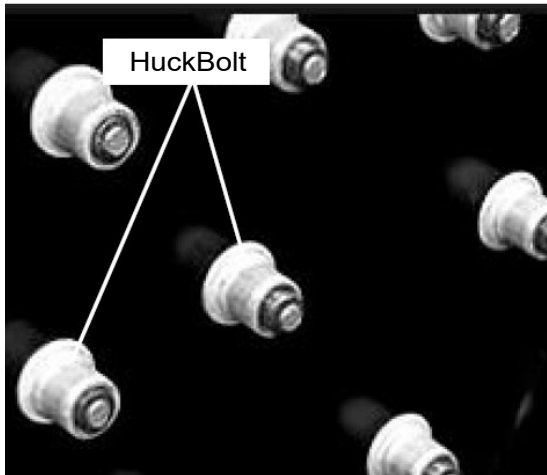
**Figure 3 — HuckBolt Fasteners**

4. Visually inspect the rear shear plate on both sides of the subbase to determine the type of fasteners used.
  - If the fasteners are HuckBolts (refer to Figure 3), proceed to step 5.
  - If the fasteners are hex bolts and nuts (refer to Figure 4), complete the Evaluation Sheet at the end of the SIL. Proceed to step 6.

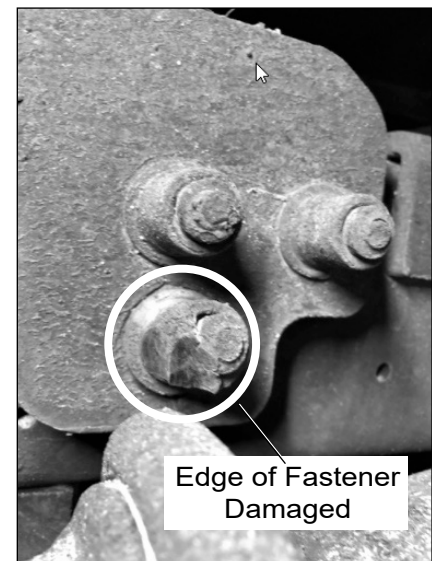
**Figure 5 — Damaged Fastener**

Altec discovered that one of the fasteners used to attach the rear shear plate on the subbase of the unit to the chassis can contact the chassis suspension U-bolt. The fastener can be a HuckBolt or a hex bolt and nut. Movement of the U-bolt can possibly cause damage to the HuckBolt or hex bolt and nut resulting in the fastener being broken off.

5. Visually inspect the HuckBolts. If needed, use soap and water or a suitable cleaning solution to remove dirt and debris from the shear plates and HuckBolts. Using a flashlight, look for signs of chassis suspension U-bolt interference with any of the HuckBolts, such as denting or metal chipping (refer to Figure 5).
  - If no sign of interference is observed, complete the Evaluation Sheet at the end of the SIL. Proceed to step 6.
  - If interference is observed, call 1-877-GO ALTEC (1-877-462-5832) to order the Bolt Kit, p/n 991251495 (includes parts for both sides), and schedule the installation of the kit within 30 days of the inspection. The kit will replace the HuckBolts with hex bolts and nuts. Do not complete the Evaluation Sheet at the end of the SIL. Proceed to step 6.
