# cummins 3382 fault

**cummins 3382 fault** Feb 5, 2021 4:57 PM

cummins isx esn- 79900989 in a freightlinerr Cascadia vin-Hx1238.

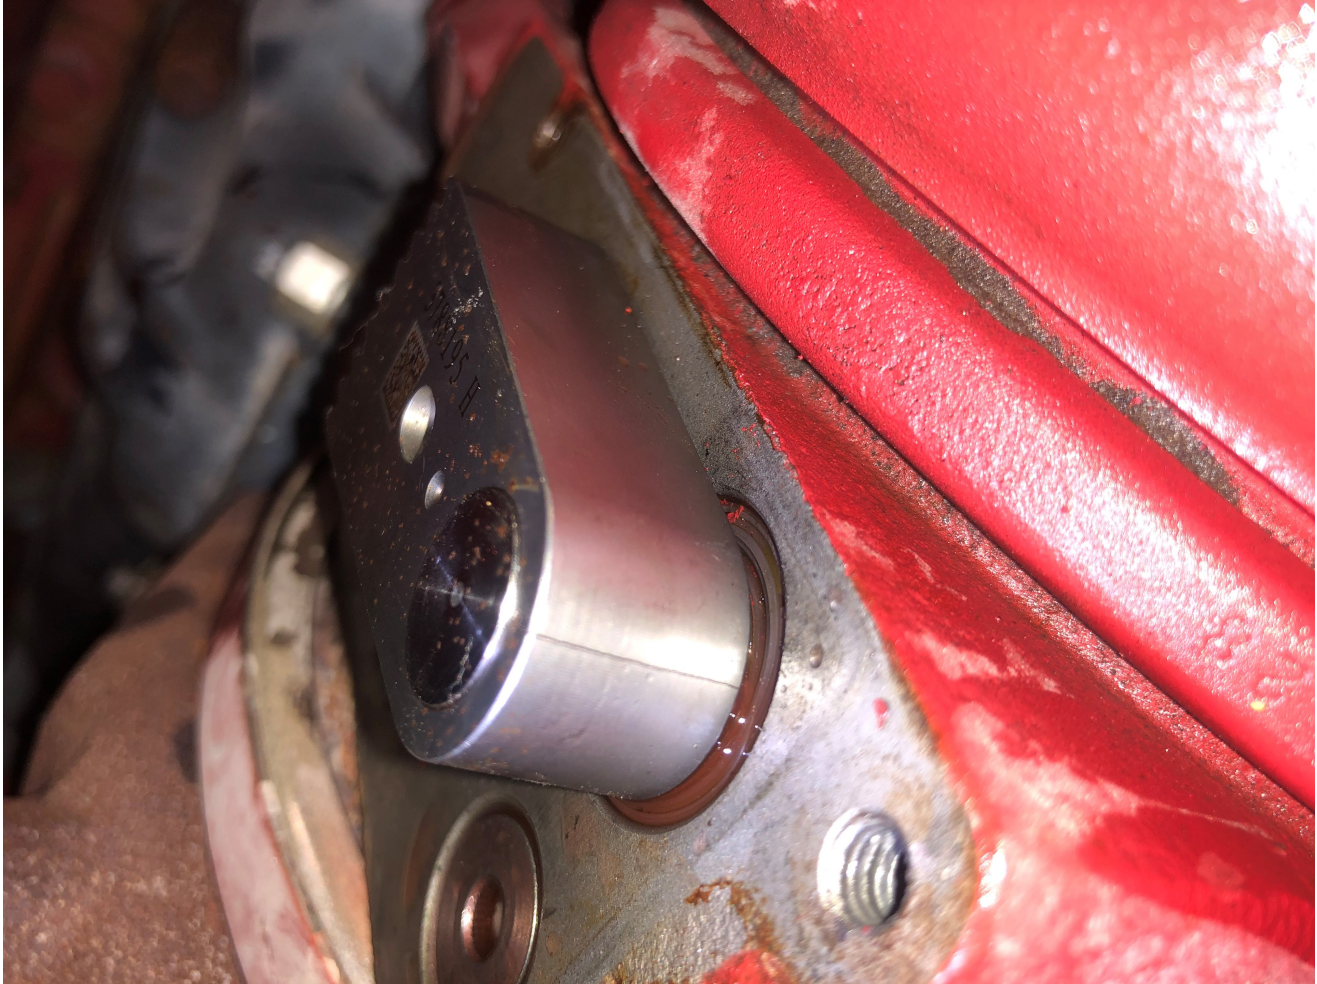
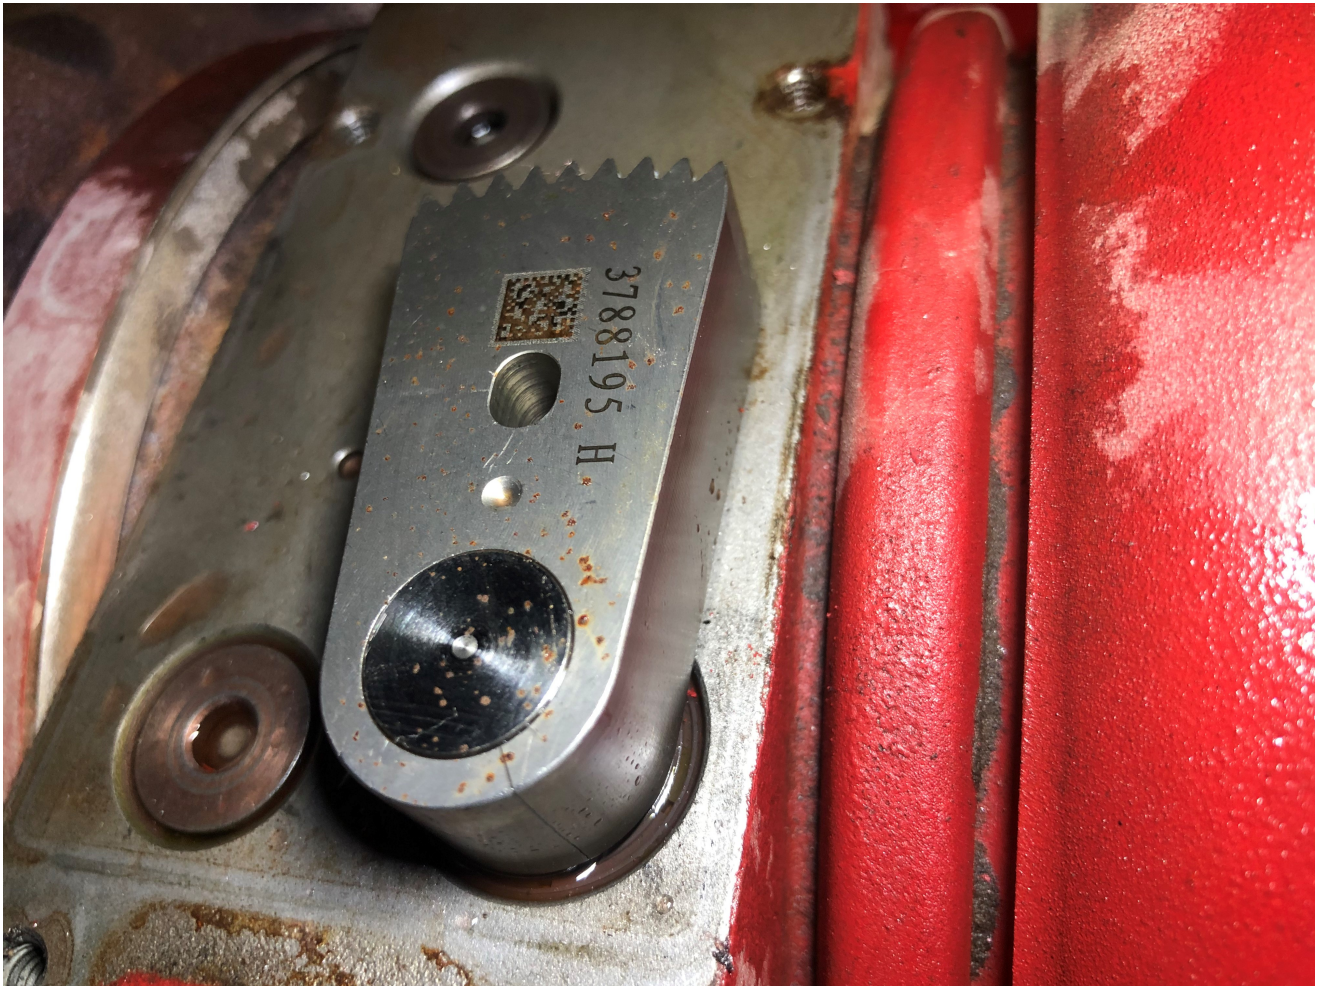
this unit came in for the engine being hydro-locked. at that time we replaced the turbo/ vgt,egr cooler, doc,dpf,scr. it kept coming back for a 3383 low egr flow fault. it would only throw the fault when under a load . we ran through guidnaz a few times it got an egr valve and a few egr diff pressure sensors. escalated it to level 3. we rplaced the ecm, engine harness, throttle intake valve, and another egr cooler, they sent us a remote data link so they could monitor the data and run tests . they ran a special vgt/egr test and it failed twice.

I removed the vgt actuator to find a crack on the sector gear.see images . I hope this helps someone this truck has been here on and off for months

Ha! The new turbo sector gear had a crack in it! Thats frustrating! Thanks for sharing. I have never checked for that. Bookmarked this post.

I have seen it, this occurs if the installation and calibration procedure is ran in the wrong order or if the sector gear is in the incorrect position when the actuator is installed and the sector gear cracks during the calibration of the actuator. One would think the calibration would fail but I've seen it pass. One would also think that it would've been caught when it was assembled at the factory. Great find.
