# Technical Service Bulletin

| <b>Subject:</b><br><b>RATTLE NOISE FROM FRONT SUSPENSION WHEN DRIVING OVER BUMPS</b> | <b>Bulletin No.:</b> 02-004/21 |
| | <b>Last Issued:</b> 02/22/2021 |

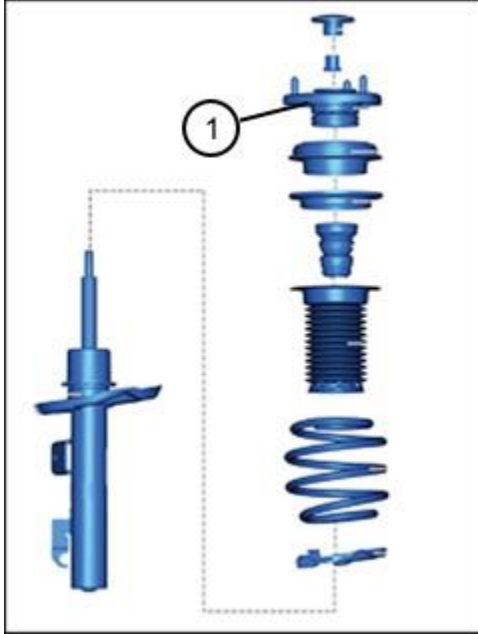
Some vehicles may exhibit a rattle noise from the front suspension when driving over bumps or on a road with a wavy surface. The noise may be caused by the mounting rubber (1) because of insufficient clearance between the rubber and the metal bracket of the mounting rubber during the assembly process. To correct this issue, the mounting rubber has been modified to ensure the proper clearance.

Customers having this concern should have their vehicle repaired using the following repair procedure.

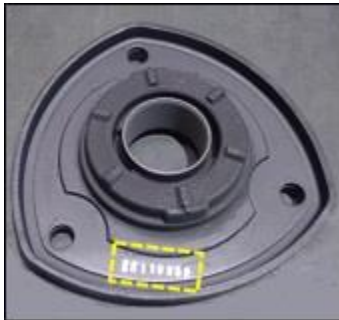
- Modified mounting rubber BCKE-34-380B is of the same part number as before, but with the production date stamped in white letters on the back of the part. The modification has been implemented from Nov. 21, 2019. Sample image shows back of the mounting rubber.
- BCKE-34-380C and BDTS-34-380B are modified parts regardless of the production date.
