Subject: FRONT DOOR INTERFERES REAR DOOR GARNISH	Bulletin No.: 09-007/21
	Last Issued: 02/25/2021

2019-2020 Mazda3 5-door HB (Japan built) with VINS lower than JM1BP*****158118 (produced before November 29, 2019)

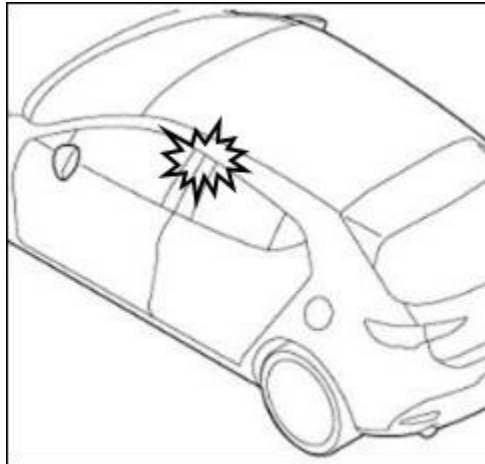
Some vehicles may exhibit that the glass run channel of the front door interferes with the rear door garnish.

Since the front door glass run channel is not fixed to the door strongly enough for the following situations, cycles of door operation may result in interference and lead to damage on the seal rubber at the rear door.

- When the front door glass is closed, the glass run channel may be forced to move to the B pillar side.
- In very hot climates, the glass run channel may expand to the B pillar side.

1. Verify customer concern.
2. Replace the front door glass run channels with modified ones, regardless if the other side is damaged or not.

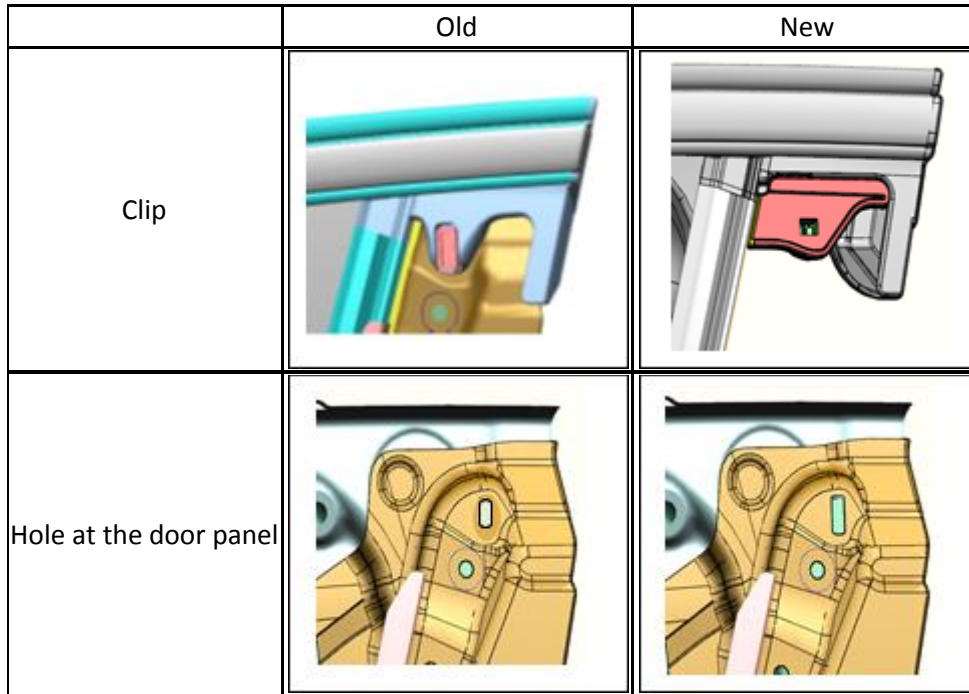
- Phase 2
 - The shape of the front door glass run channel has been changed so as not to make contact with the rear garnish.
 - The shape of the clip at the rear side of the front door glass run channel has been changed for stronger fixing and the hole at the door panel has been changed accordingly.
