# DPF inspection

**DPF inspection** Feb 17, 2021 7:01 PM

Just removed DPFs on a 2019 New Cascadia DD15 vin KN8131 with 450,000 miles. Normally we install reman filter, due to a back order we need to clean the filters to get this unit back on the road. When inspecting the DPFs after removal, I noticed brown dots on the outlet side on both filters. My question is, are these filters ok to clean or have they failed? I believe they have failed but I've been wrong before and I need a second opinion.

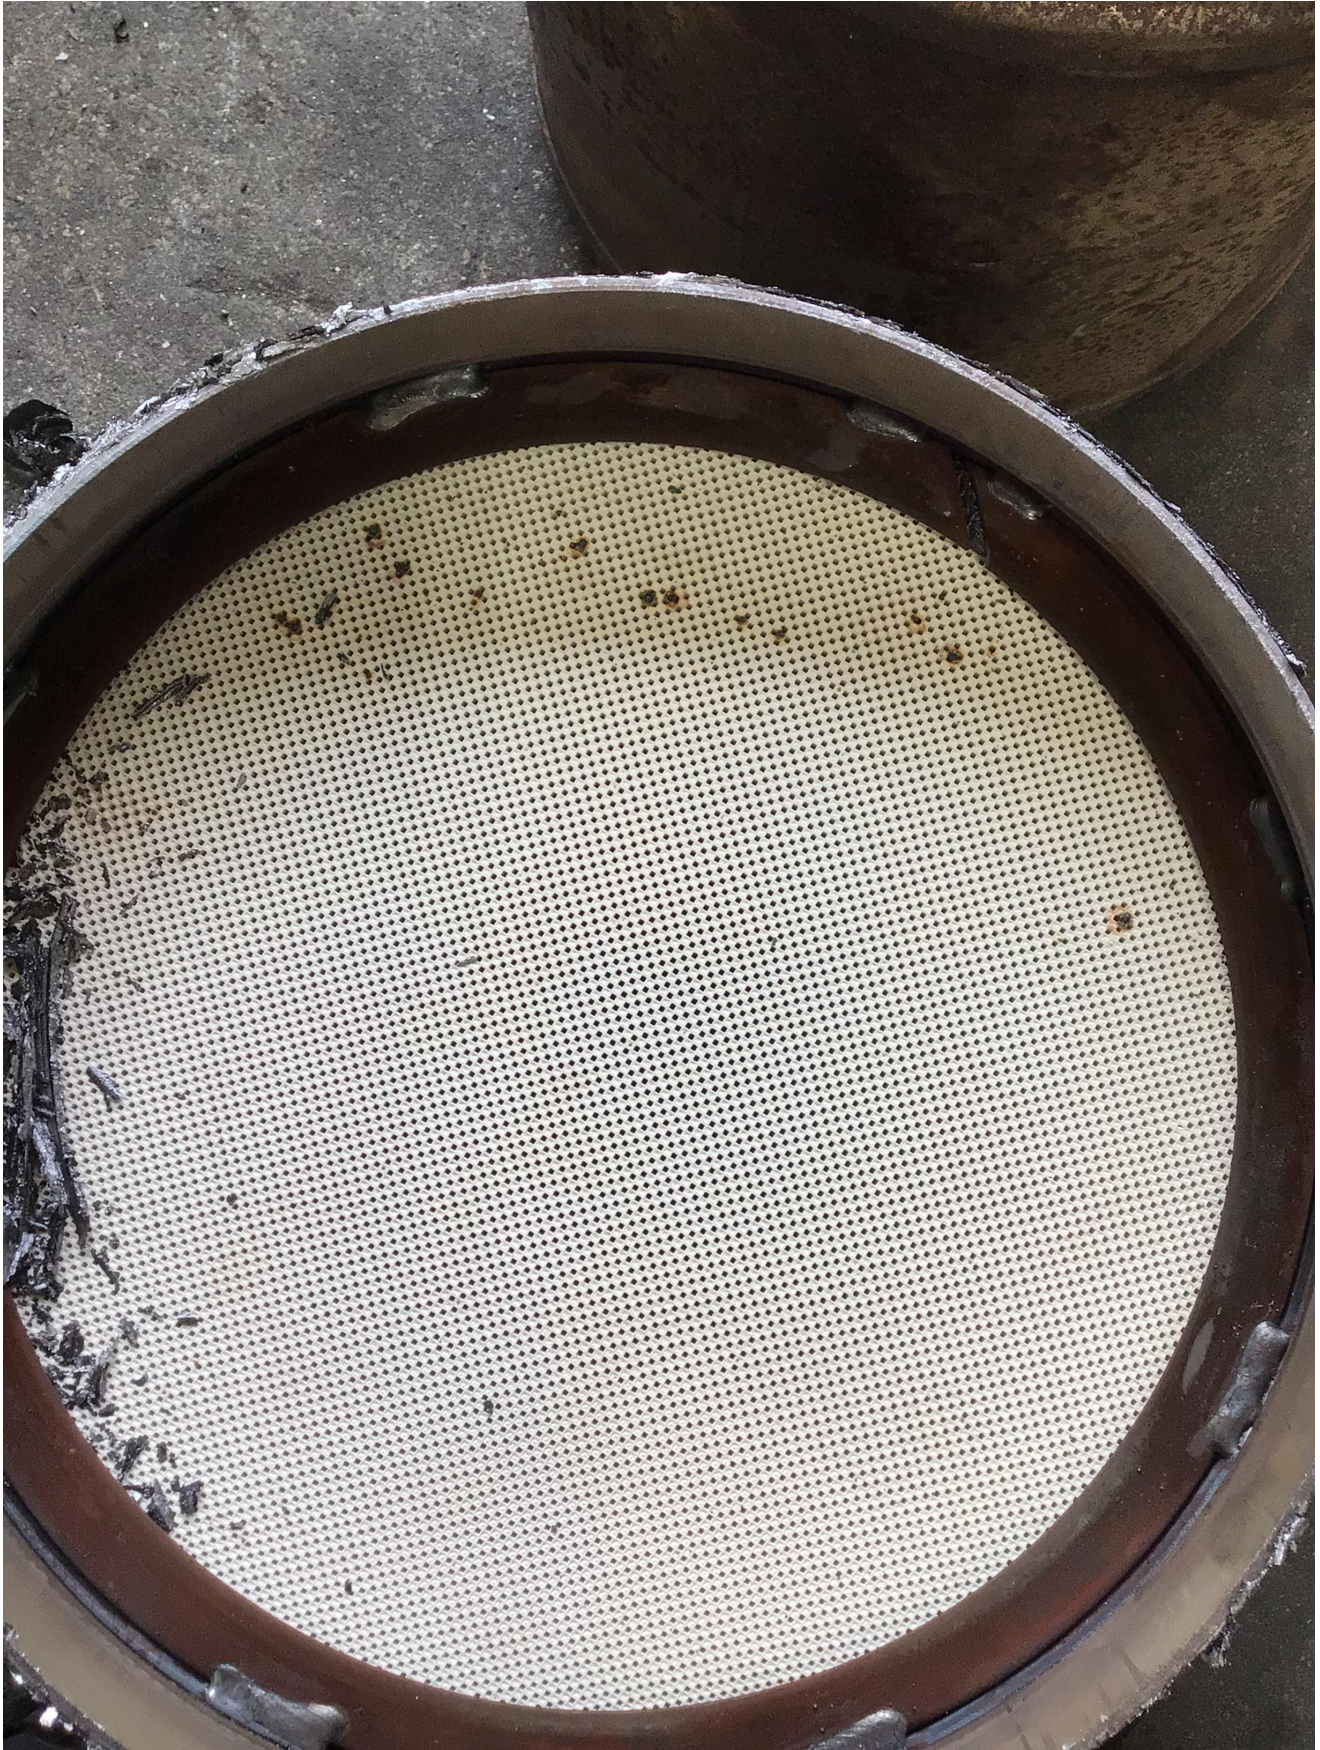
The Detroit DPF inspection guide is attached. The spots you see are considered "weld splatter" and are not a concern

As said above what you see is weld splatter

I have seen something similar to this when someone has had to weld a dpf outlet temp sensor boss (bung). Some debris from welding contacted the outlet side of dpf.

Do not send the DPF's for cleaning Detroit does not recommend that. Use remans. see 14TSREV1 letter attached.

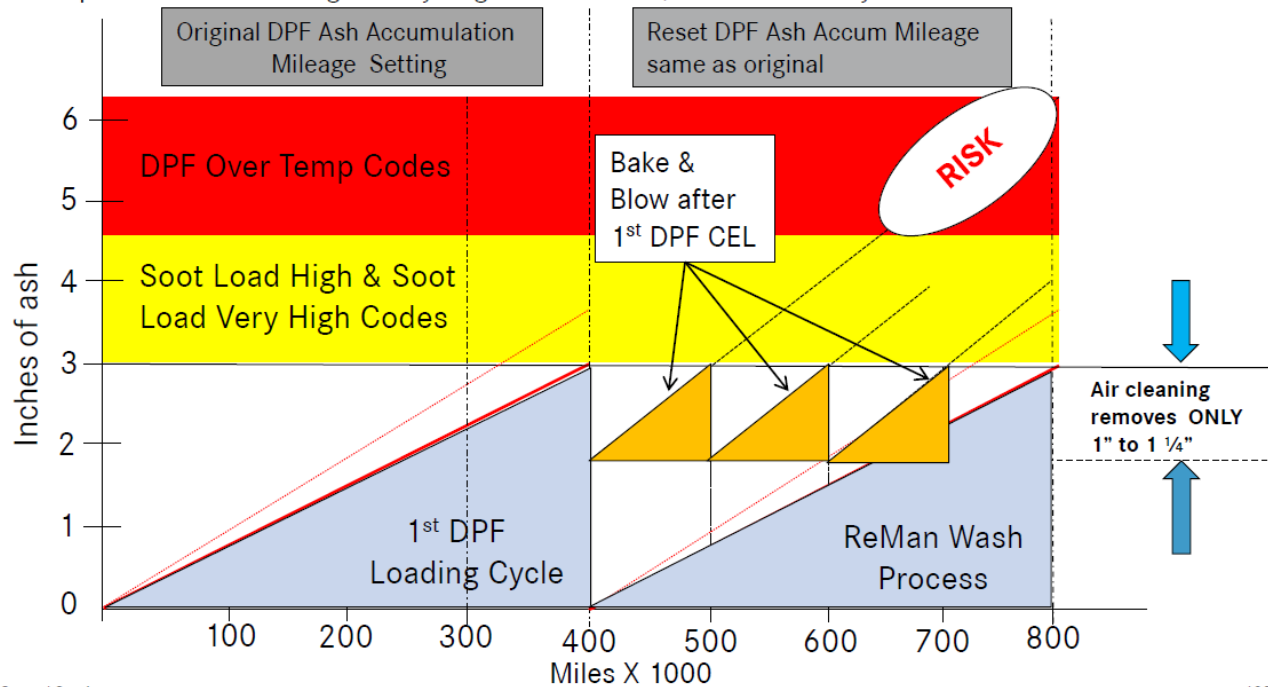
## Low NOx Conversion – Platinum Migration

- When an overtemp occurs in either the DOC (code 3250/0) or DPF (code 3246/0), platinum is released from the coating & migrates to the SCR catalysts & contaminates them. The result is low NOx conversion efficiency (code 4364/x), especially at higher operational temps.
- Air cleaning will **NOT** allow you to travel the typical 300-400,000 miles before you get another DPF Ash Clean Request code. Air cleaning will only be good for 100-125,000 miles before you start to have issues.

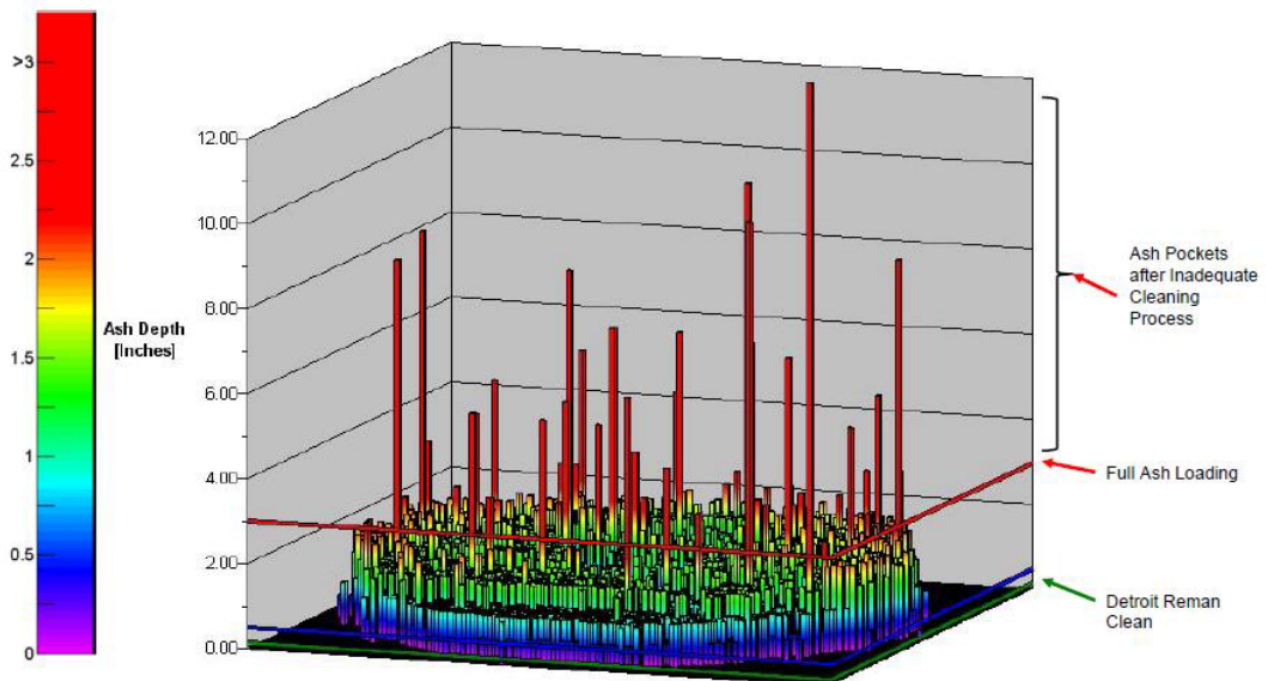
### 3D View of Ash Content After Inadequate Cleaning

- DPF will overheat if ash level in the DPF gets above 4.5" (range from 4.5"-5.25") or ash pockets are left unevenly disbursed through the substrate.
- When an EPA10 DPF Overheats (exceeds 790°C):
  - The substrate will crack allow unfiltered exhaust to pass through to the SCR
  - Platinum (the catalyst for burning the soot) vaporizes and plates out on the SCR
  - The SCR Catalyst is then "Poisoned" due to the migration of the Platinum
  - When migration occurs, the DDEC Code for "Low NOx Conversion Efficiency" illuminates the CEL
  - The One Box must be completely replaced when this occurs
- EPA10 One Box replacement cost to the customer is approximately \$15k

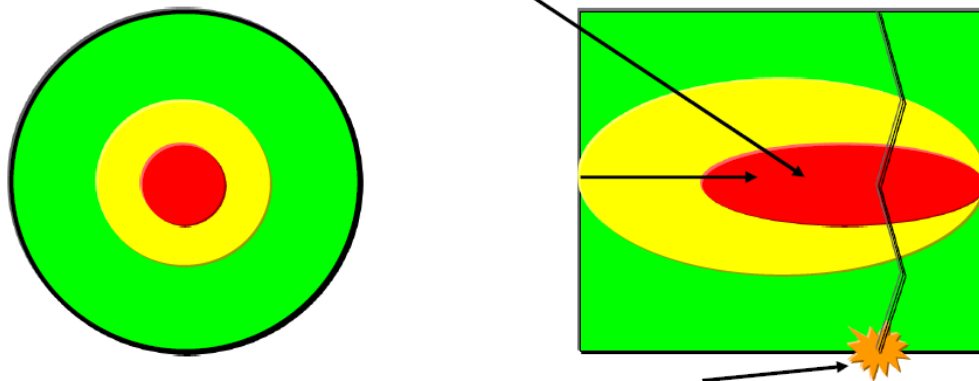
- Ash pockets are dislodged from exhaust end, but not discharged
- Ash pocket insulation creates hot and cold zones causing high thermal gradients that lead to expansion cracking.

The center of the filter expands with heating

The relatively cool edge of the DPF does not expand and is in tension while resisting the expansion of the center. If the stress becomes too high, a fracture will initiate at the rim. As a brittle material, the crack will propagate across the entire DPF immediately after initiation. The crack results in some level of leakage.
