Service Alert

CONNECTED VEHICLE SYMPTOM TROUBLESHOOTING

Service Alert No.: SA-013/21

Last Issued: 02/22/2021

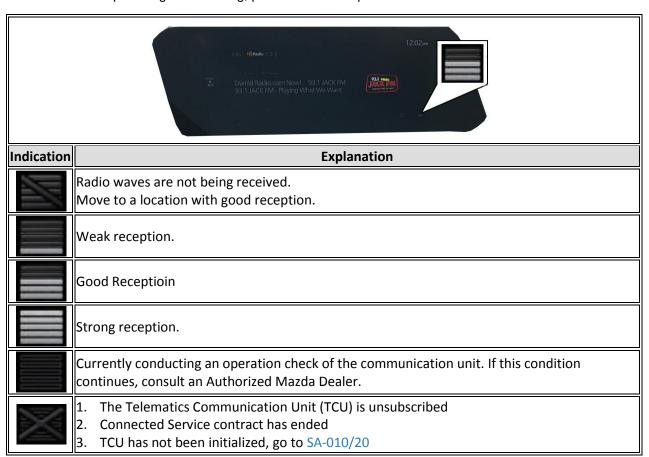
Confirm the customer's phone and vehicle have good to strong reception during the concern as shown in the table below.

- If the reception is weak, move the vehicle to a location where the reception is good to strong as shown in the table, then try to get the Authorization Code and/or operate the remote functions before proceeding to the Repair Procedure if there is still an issue.
- If the reception is good to strong, proceed to the Repair Procedure.
