Mazda North American Operations Irvine, CA 92618-2922

Subject: "LOW BATTERY RISK. START VEHICLE TO CHARGE 12V BATTERY"	Service Alert No.: SA-005/21
WARNING MESSAGE	Last Issued: 02/10/2021

2021 Mazda3 2021 CX-30

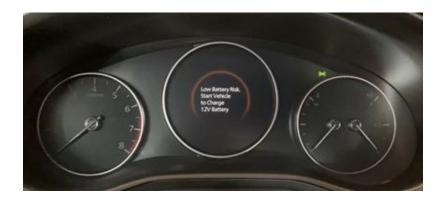
Some vehicles may have a "Low Battery Risk. Start Vehicle to Charge 12V Battery" warning message in the instrument cluster and a 30 second alarm sound. This is caused by

the vehicle's electrical control area network (CAN) entering "Sleep Mode" when the network awake time reaches 30 cumulative minutes without the engine running.

No dealer visit is required. The warning message can be cleared by starting the engine and idling or driving for 5 minutes or longer.
